PROJECT 'PURCHASE OF STUDIES FOR THE PREPARATION OF A DESIGNATED SPATIAL PLAN AND THE ASSESSMENT OF IMPACT'

ACTIVITY 4. STUDIES FOR THE ELIMINATION (DECOMMISSIONING) OF THE REACTOR COMPARTMENTS

INTERIM REPORT

RAJALA

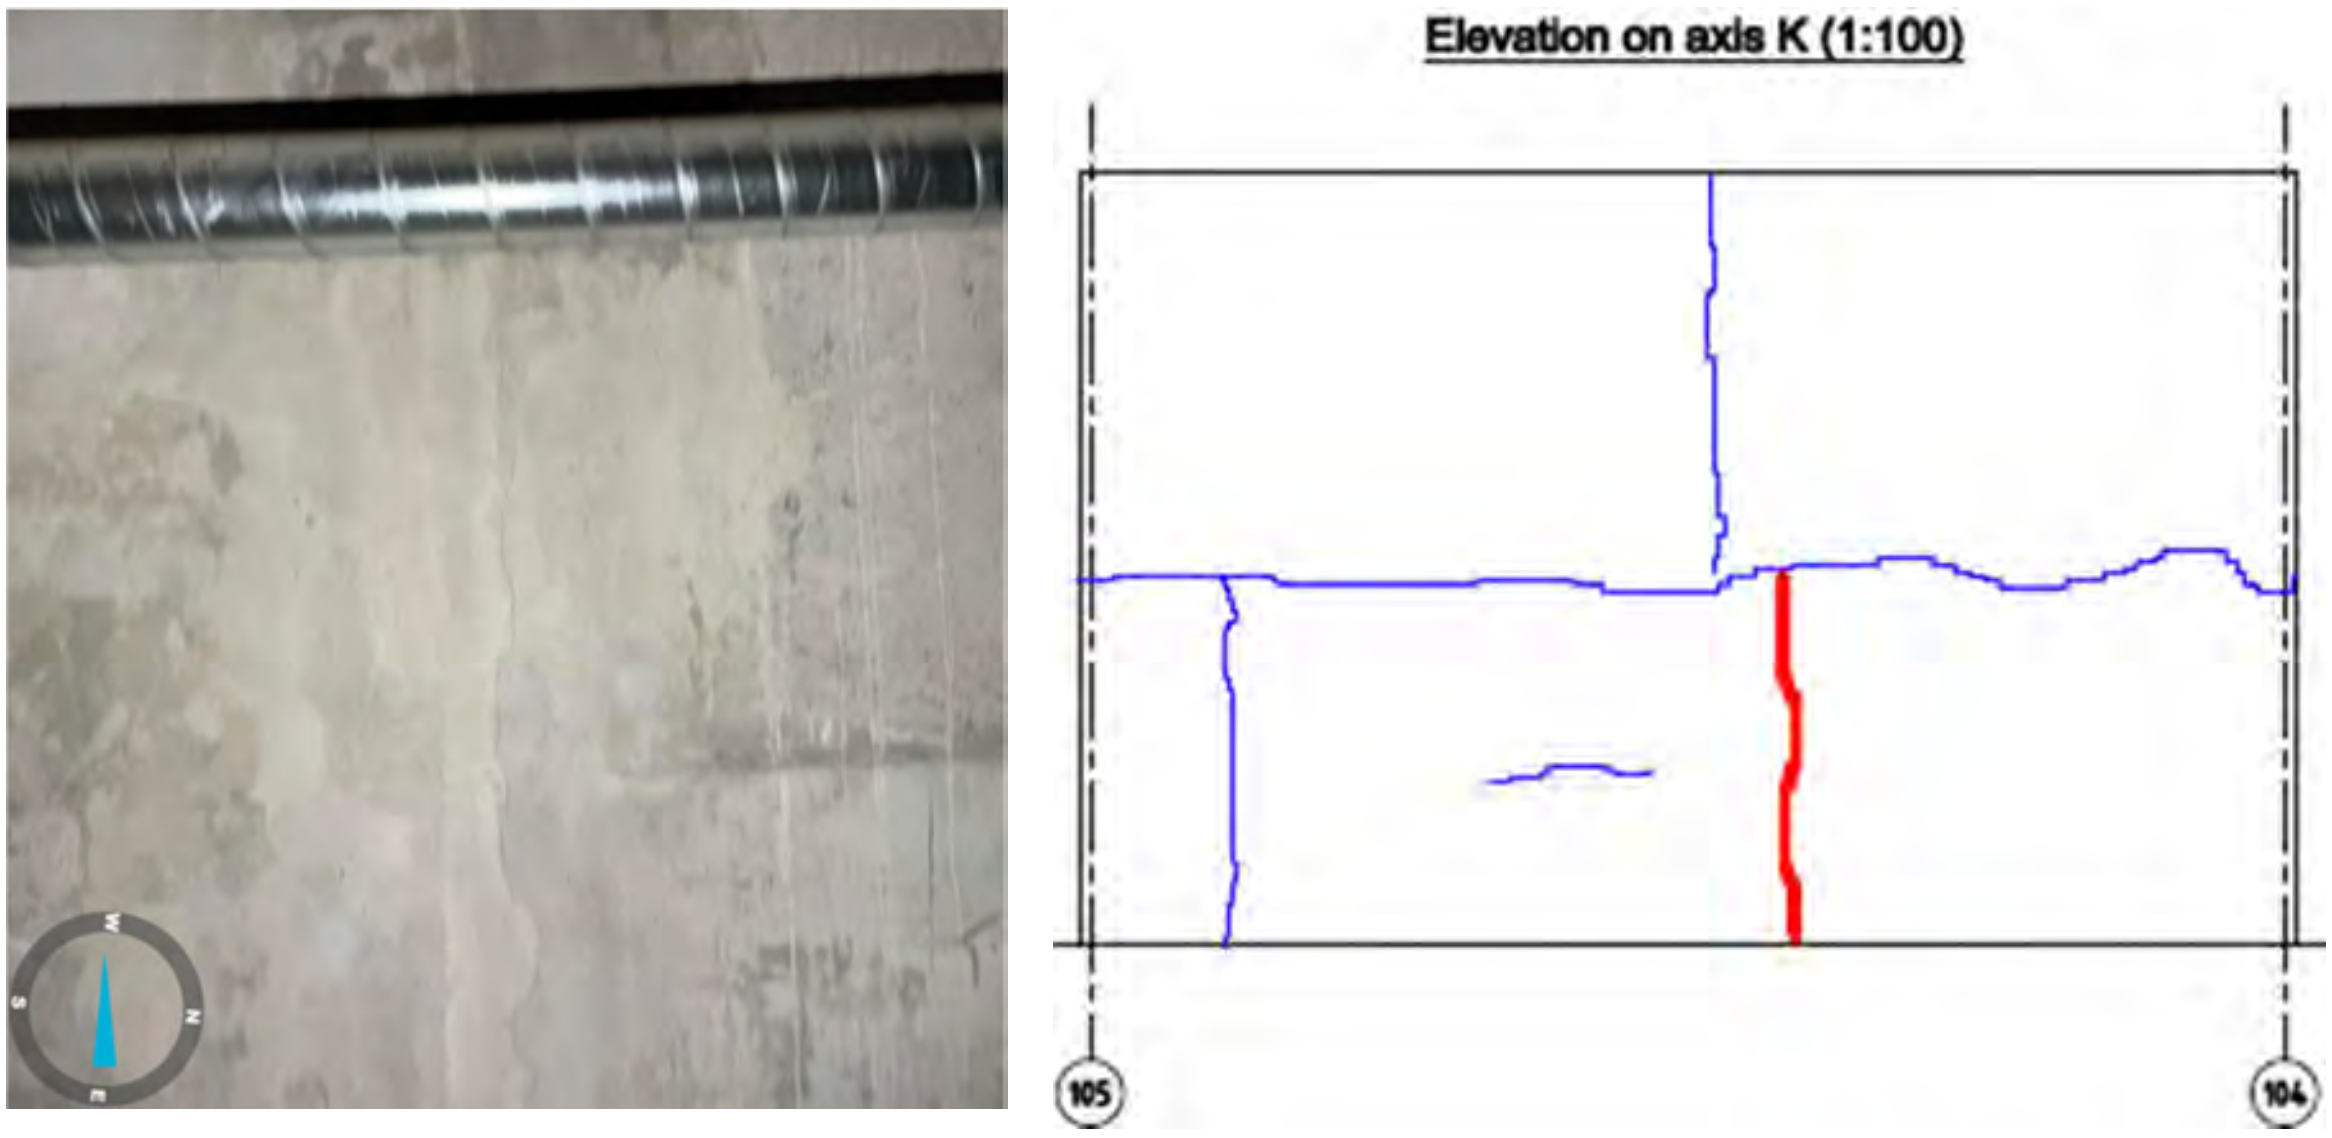
A considerable vertical crack, that is not repaired, with a depth of at least 20 cm, measured with an ultrasonic device, runs in the wall (see Fig. 2). Other cracks follow the lines of work joints.

Fig. 2. Cracks on the wall of Interim storage (existing crack red marked, repaired cracks blue marked)

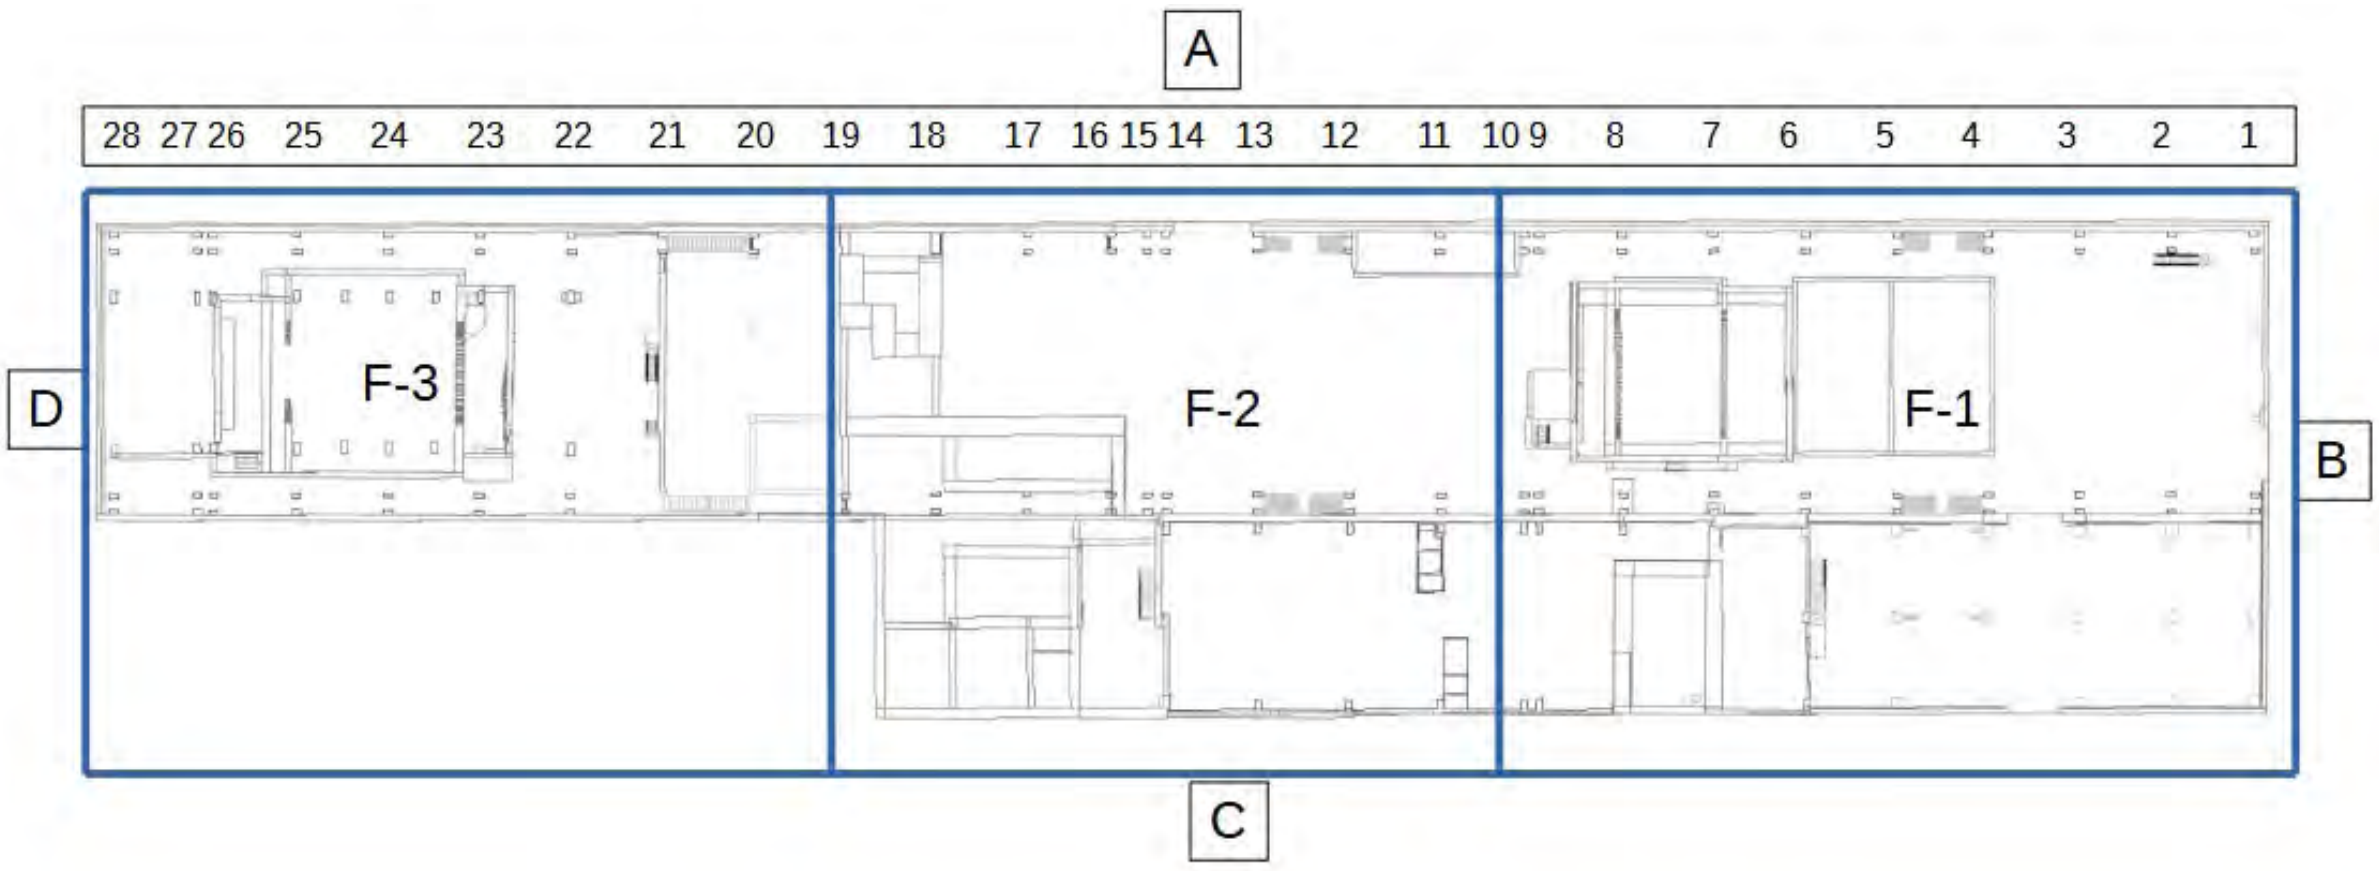
Fig. 1. Scheme of the control area

The scheme of the control area of the main building is shown in Fig. 1. For display convenience of the survey results, three zones (F-1, F-2, and F-3), walls (A, B, C, D) and pillars (1 ÷ 28) are marked in the scheme.

The data of averaged gamma-ray dose rates (µSv/h) around shown point results of a survey in the control area with unshielded devices was collected during the measurement campaigns. The uncertainty of measurements is lower than 20 percent.

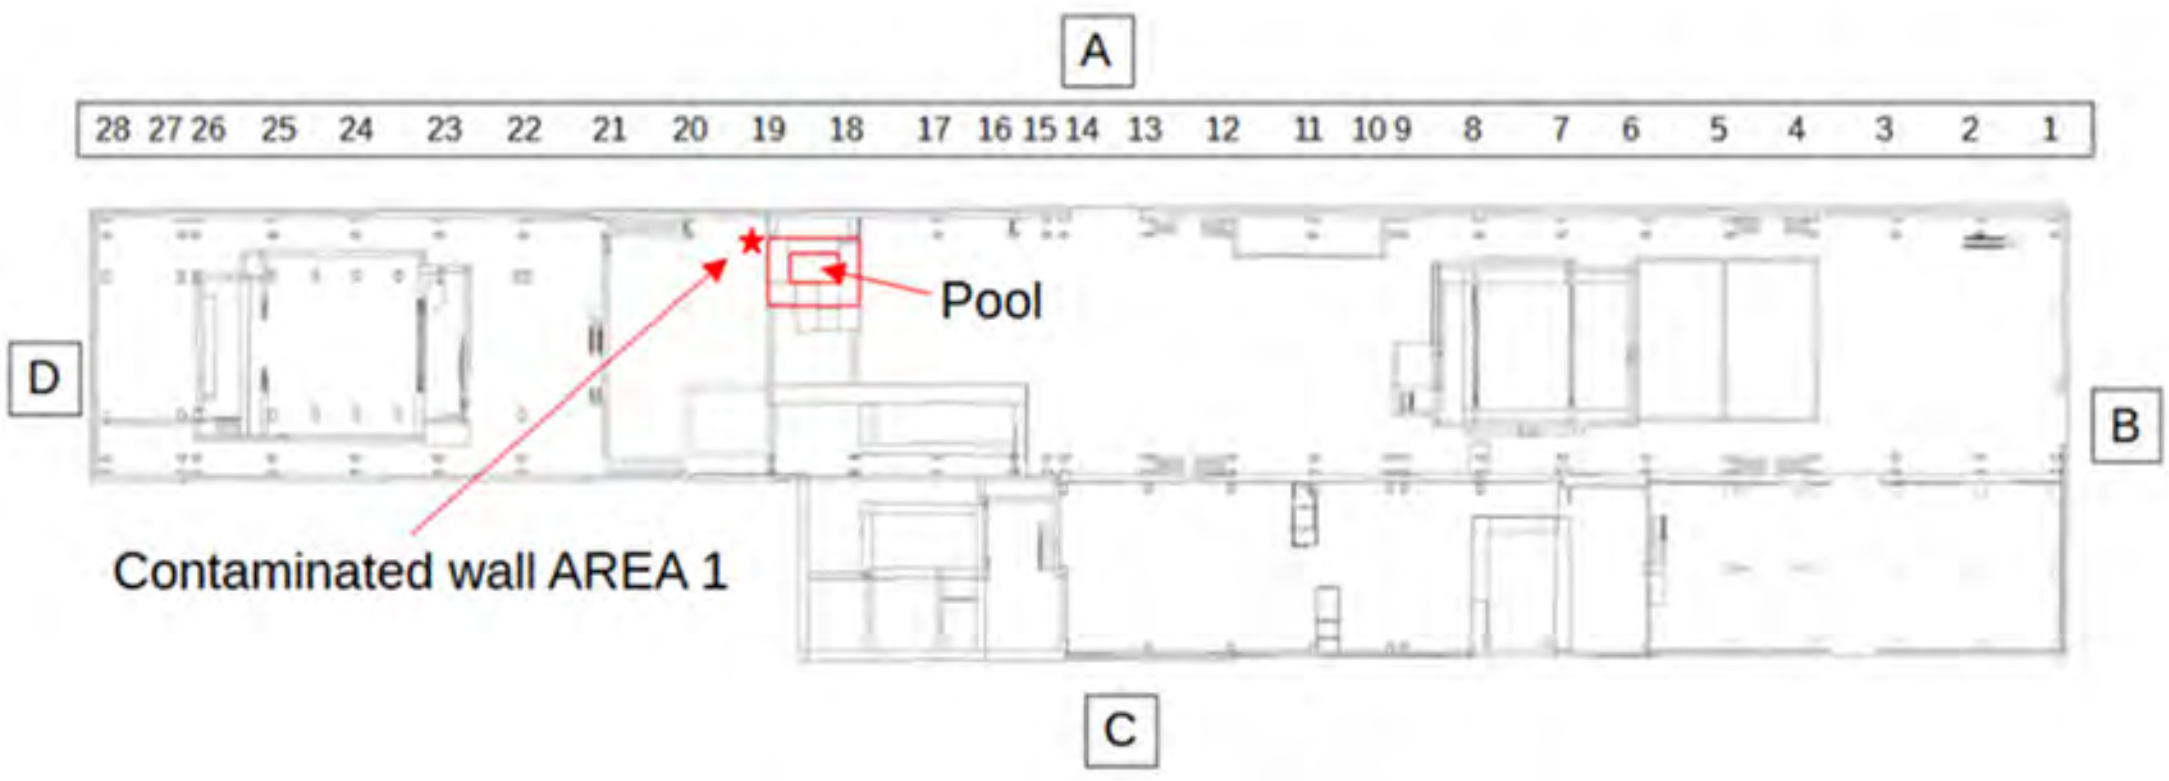
There is also an increased gamma-ray dose rate near the interim storage caused by the waste inside the storage. These conclusions have been confirmed by gamma-ray dose rate measurements by collimated with lead shielding measuring instruments. The gamma-ray dose rate was below 0.2 µSv/h when shielded devices were used in all places, where gamma-ray dose rates higher than 0.2 µSv/h was obtained with unshielded devices. The increase in the gamma-ray dose rate in some places is caused by containers with waste from current waste management activity. The measurements with shielded instruments confirmed the presence of the contaminated area. The contaminated area (AREA 1) is located on the wall of a nuclear pool near the reactor compartment No. 1. The location and dimensions of the contaminated area are shown in Fig. 2 and Fig. 3. The biggest value of gamma-ray dose rate in this contaminated area is equal to 0.28 µSv/h. The gamma-ray dose rate measurements inside the nuclear fuel pool resulted in gamma-ray dose values up to 1.8 µSv/h near the bottom (see Figs. 5, 6).

Fig. 2. Contaminated area (AREA 1) in the main building

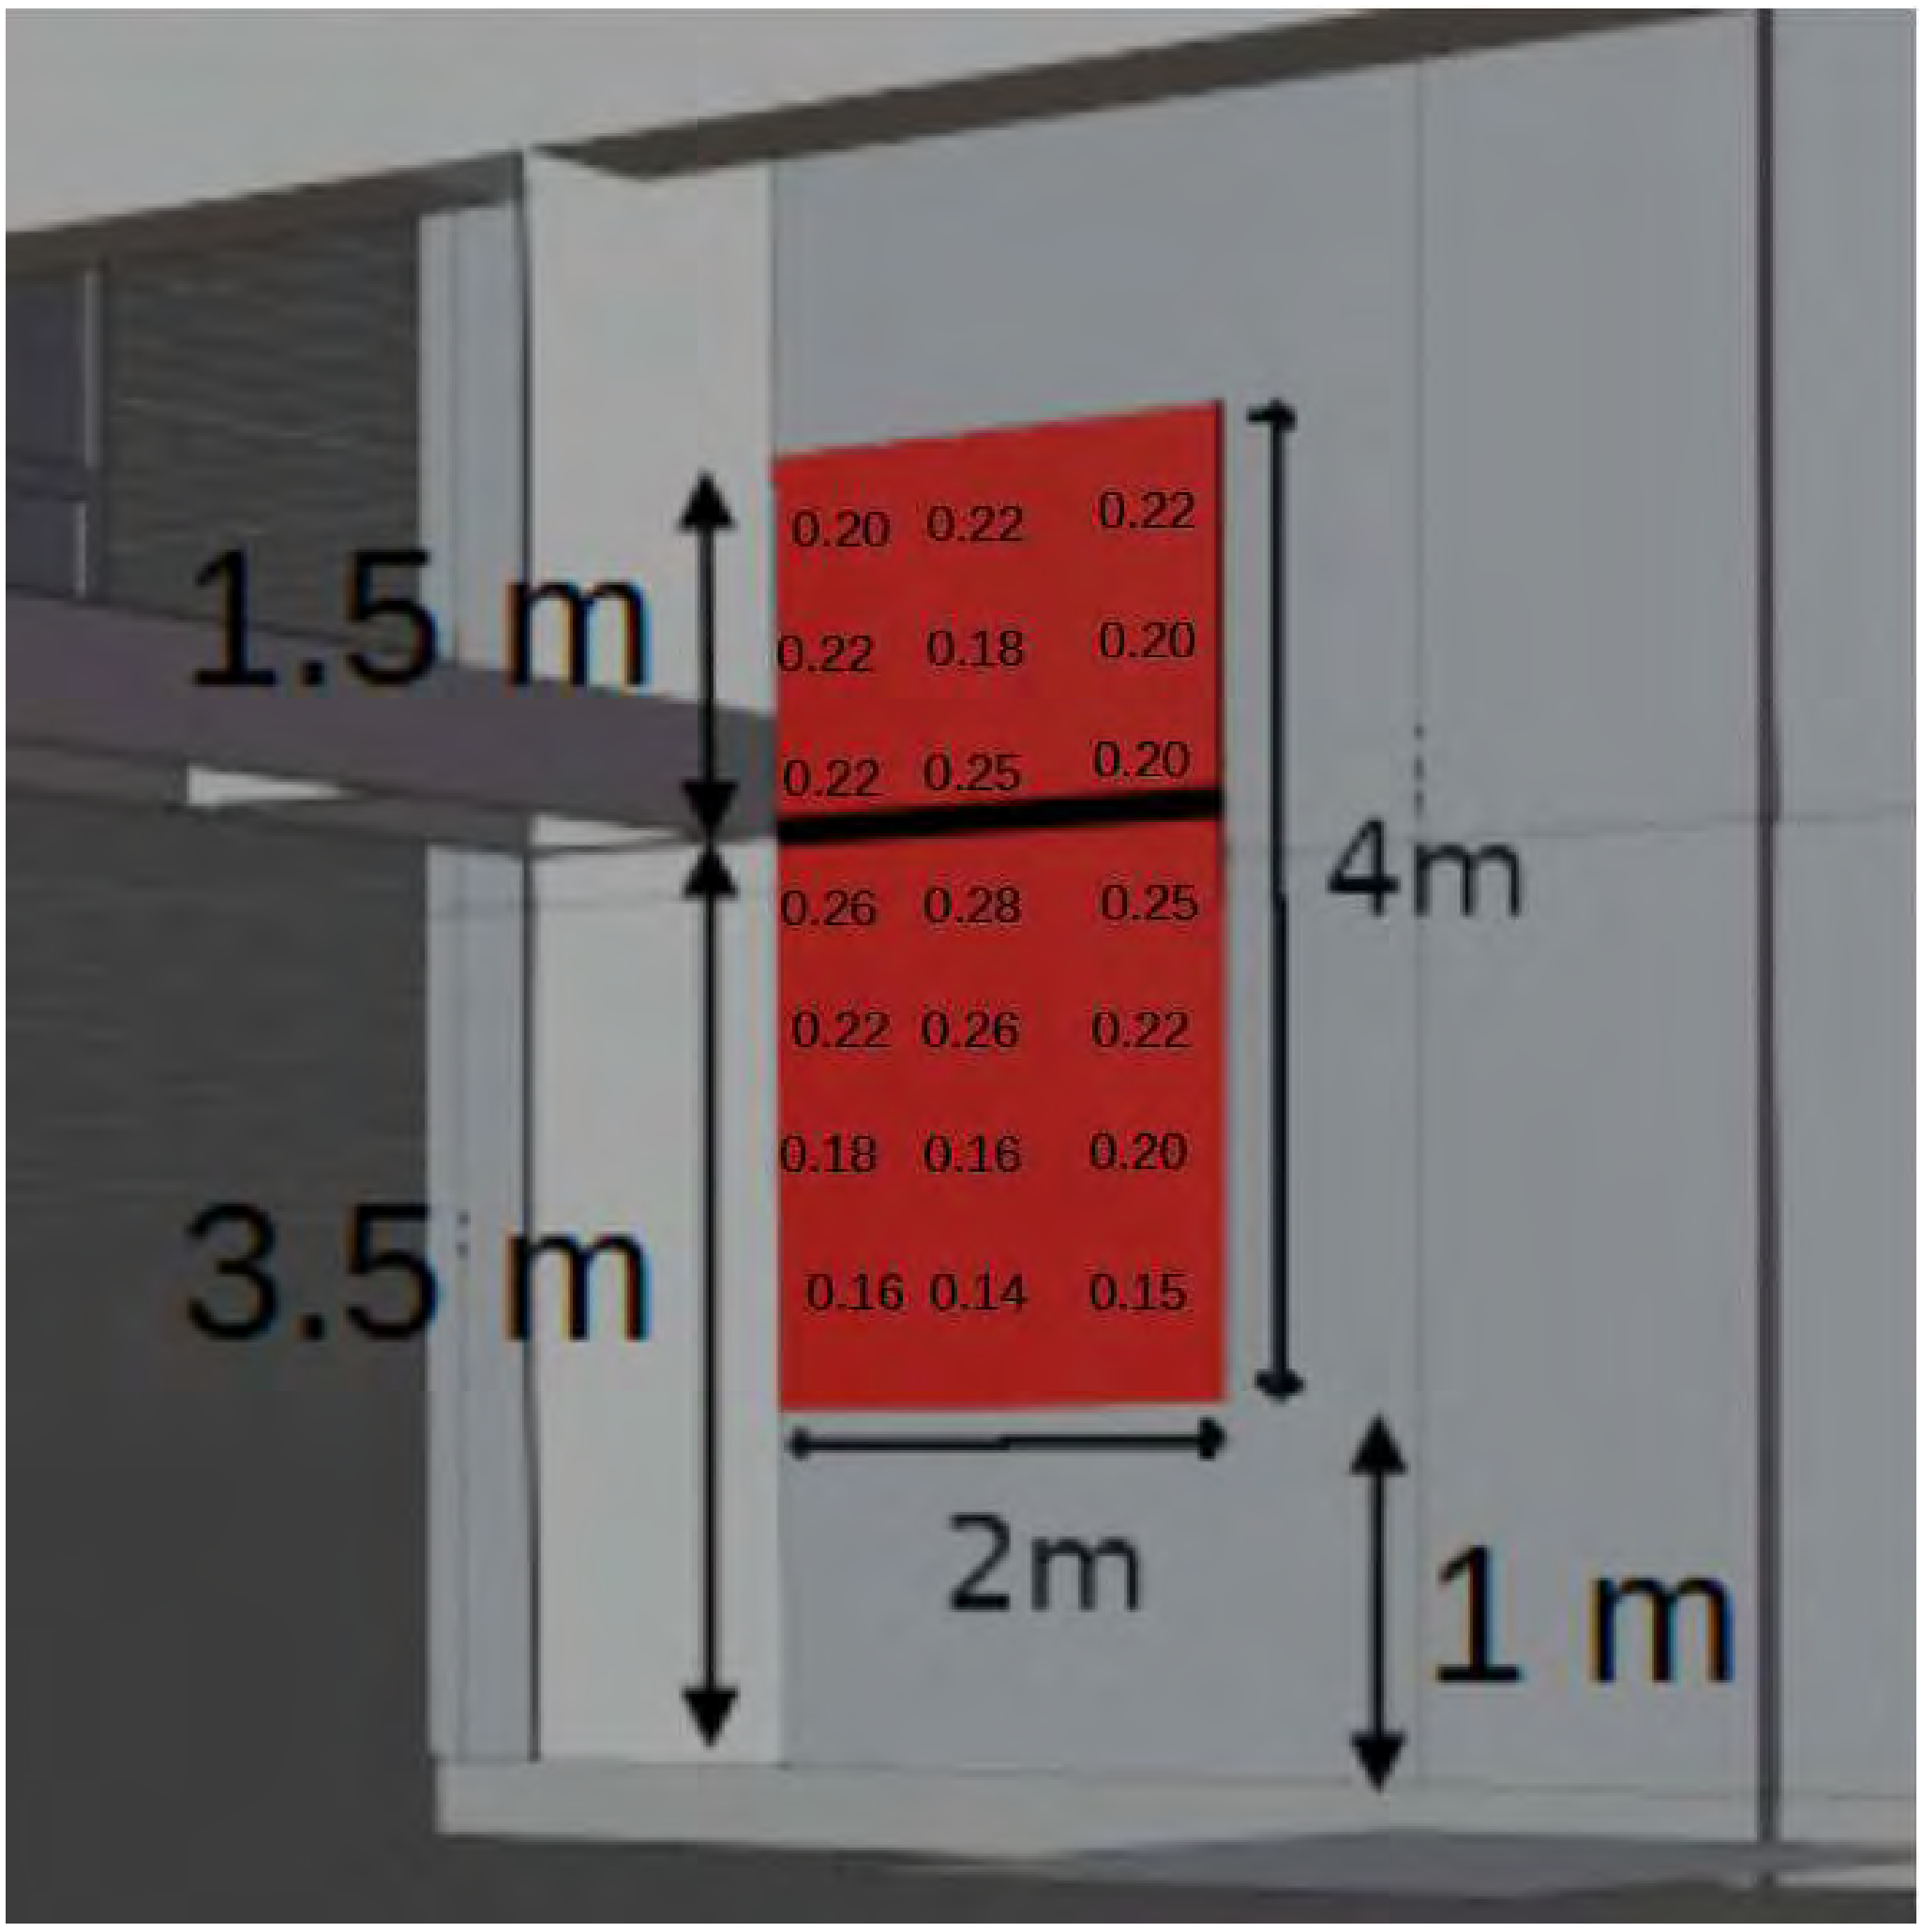
Fig. 3. Gamma-ray dose rate (µSv/h) in the contaminated area (AREA 1) of the main building

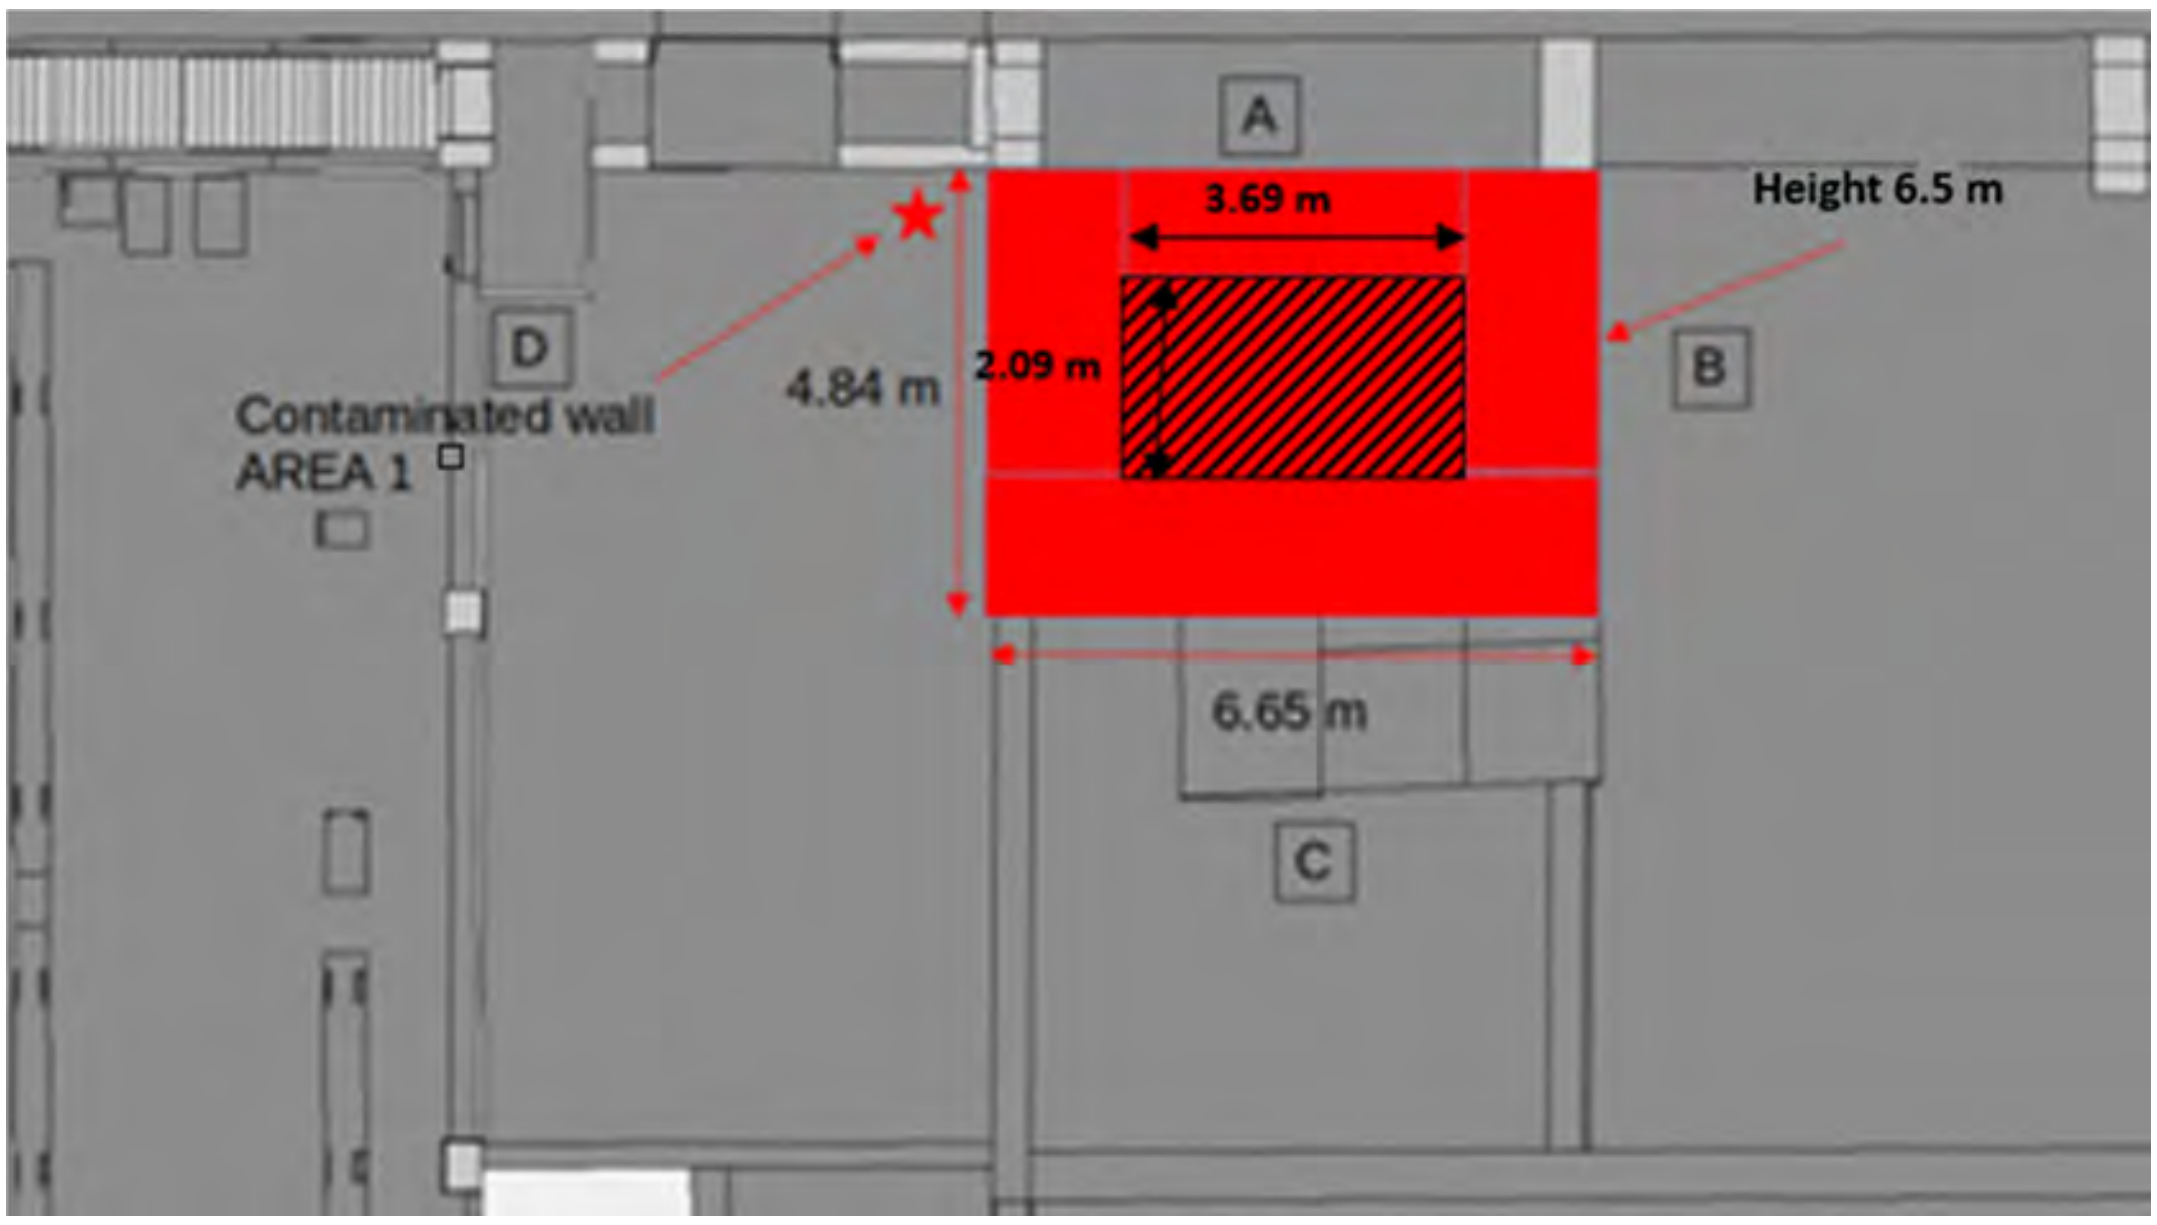
Fig. 4. Location and dimensions of the contaminated nuclear fuel pool

The internal surface of the nuclear fuel pool was decontaminated. The biggest part of the surface is clean according to smear tests. Most samples have activity concentrations lower than exclusion and clearance levels. Activity concentrations in the other near-surface samples are not much higher than exclusion and clearance levels. In general, near-surface samples, including samples from open cracks are not representative for the assessment of bulk contamination, which was not affected by decontamination. However, the high gamma-ray dose rates inside the nuclear fuel pool, point out that there is bulk contamination. One can see in Fig. 5 the gamma-ray dose variation is not big, especially if a geometric factor (there is no contamination source in the upper part) and the nuclear fuel pool could not be maximum filled with water, is taken into account. These facts enable to use of simulation for conservative estimation of a gamma emitter concentration. The main gamma emitter is Cs-137 as one can see from measurement results of samples from AREA 1 and AREA 2 (see Chapter 4.7), which have not been decontaminated. For the simulation of the gamma-ray field inside the nuclear fuel pool, Microshield computer program was used. It is supposed conservatively that the Cs-137 creates the maximum measured gamma-ray dose rate. The calculated Cs-137 activity concentration together with activity concentrations of the other nuclides for the year 2041, which are calculated using the nuclide vector, is presented in Table 5.

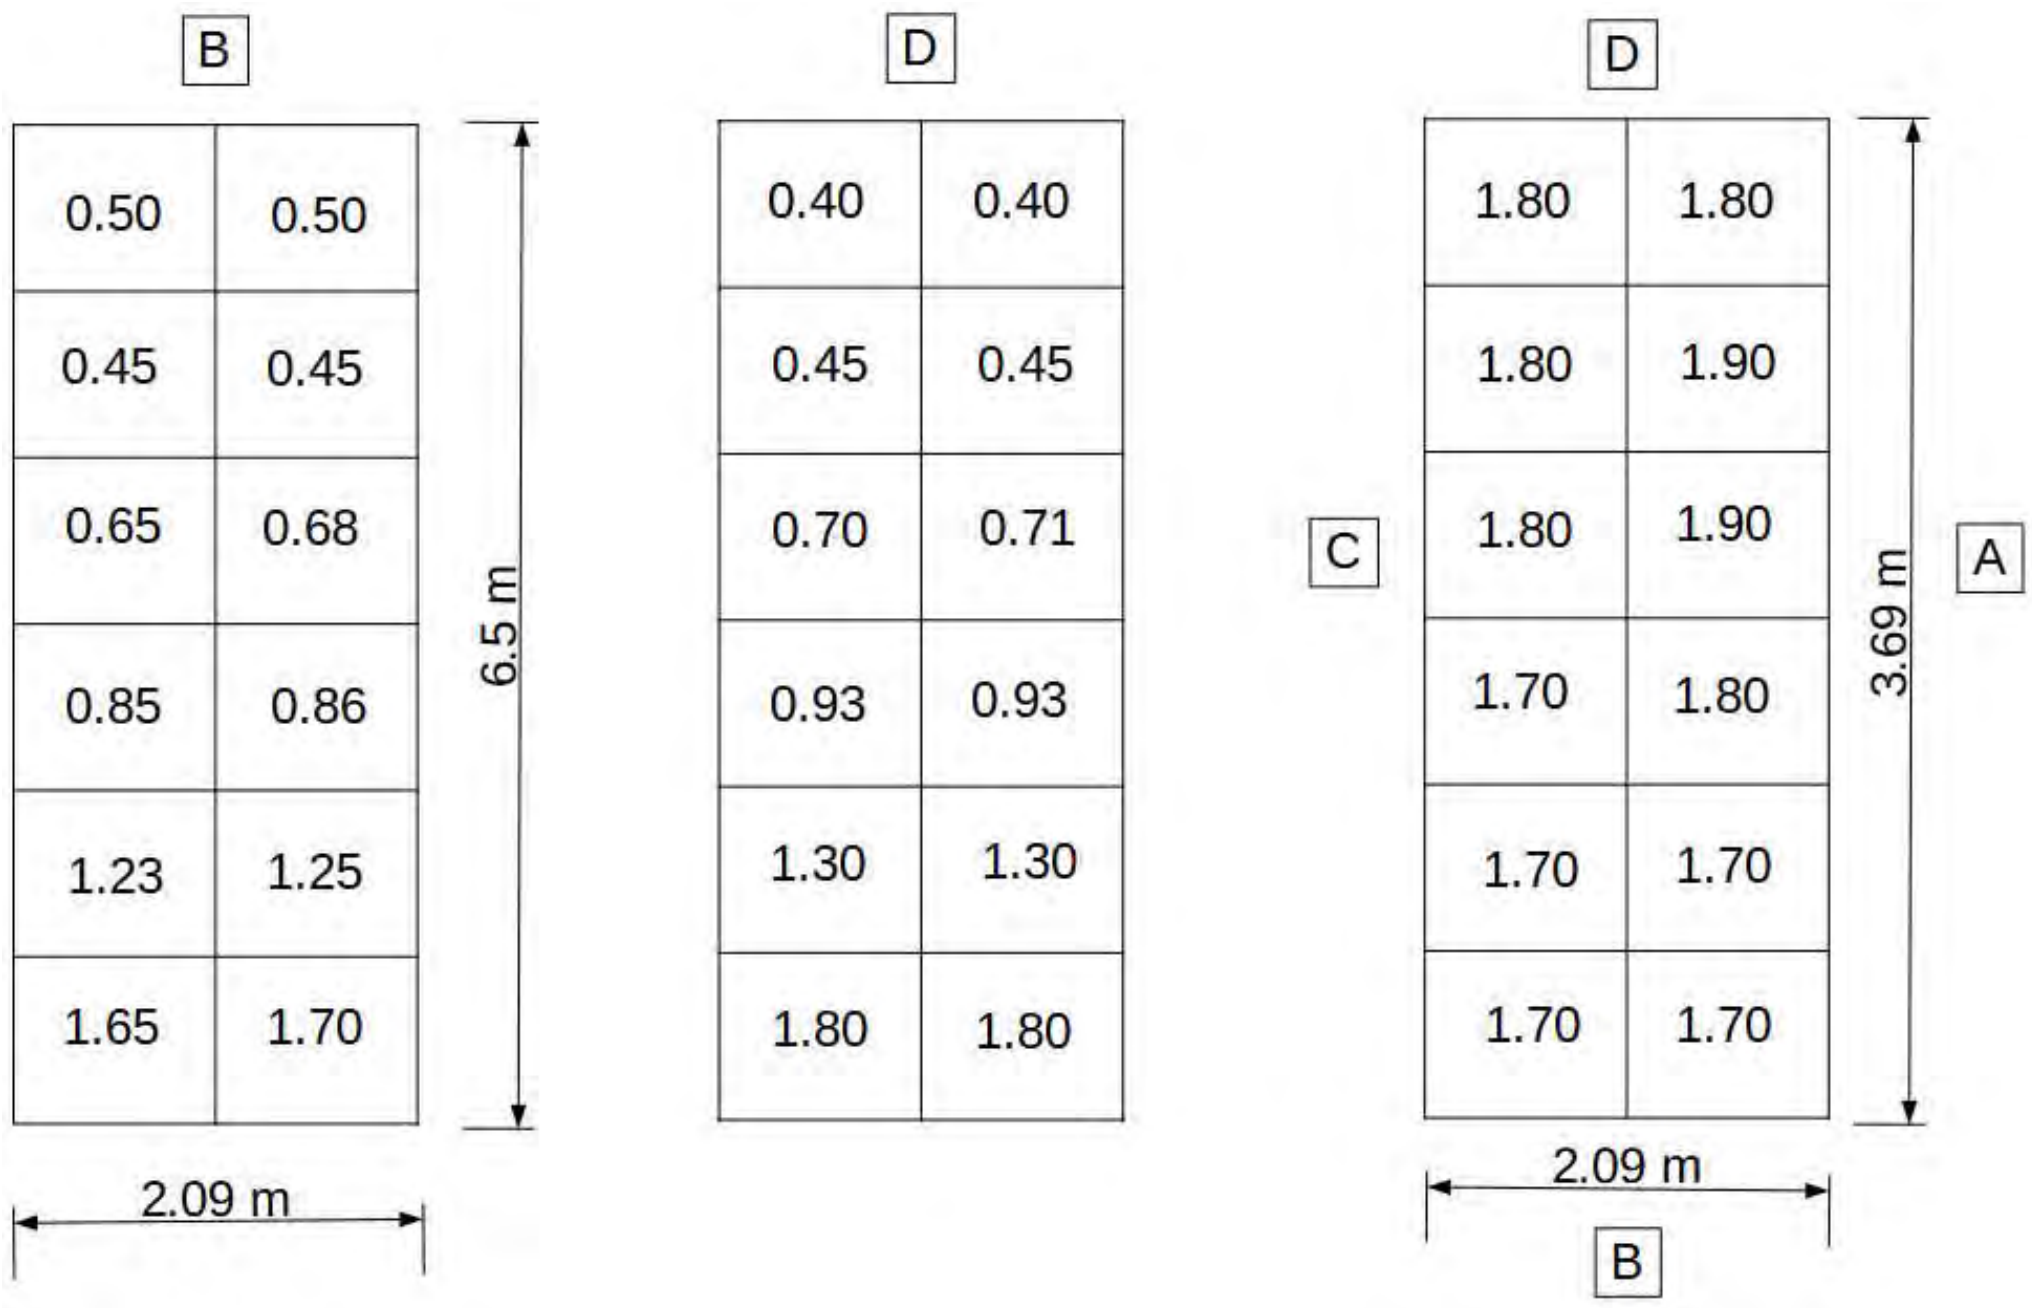
Fig. 5. Gamma-ray dose rate (μSv/h) measured on the floor and B, D walls in the nuclear fuel pool

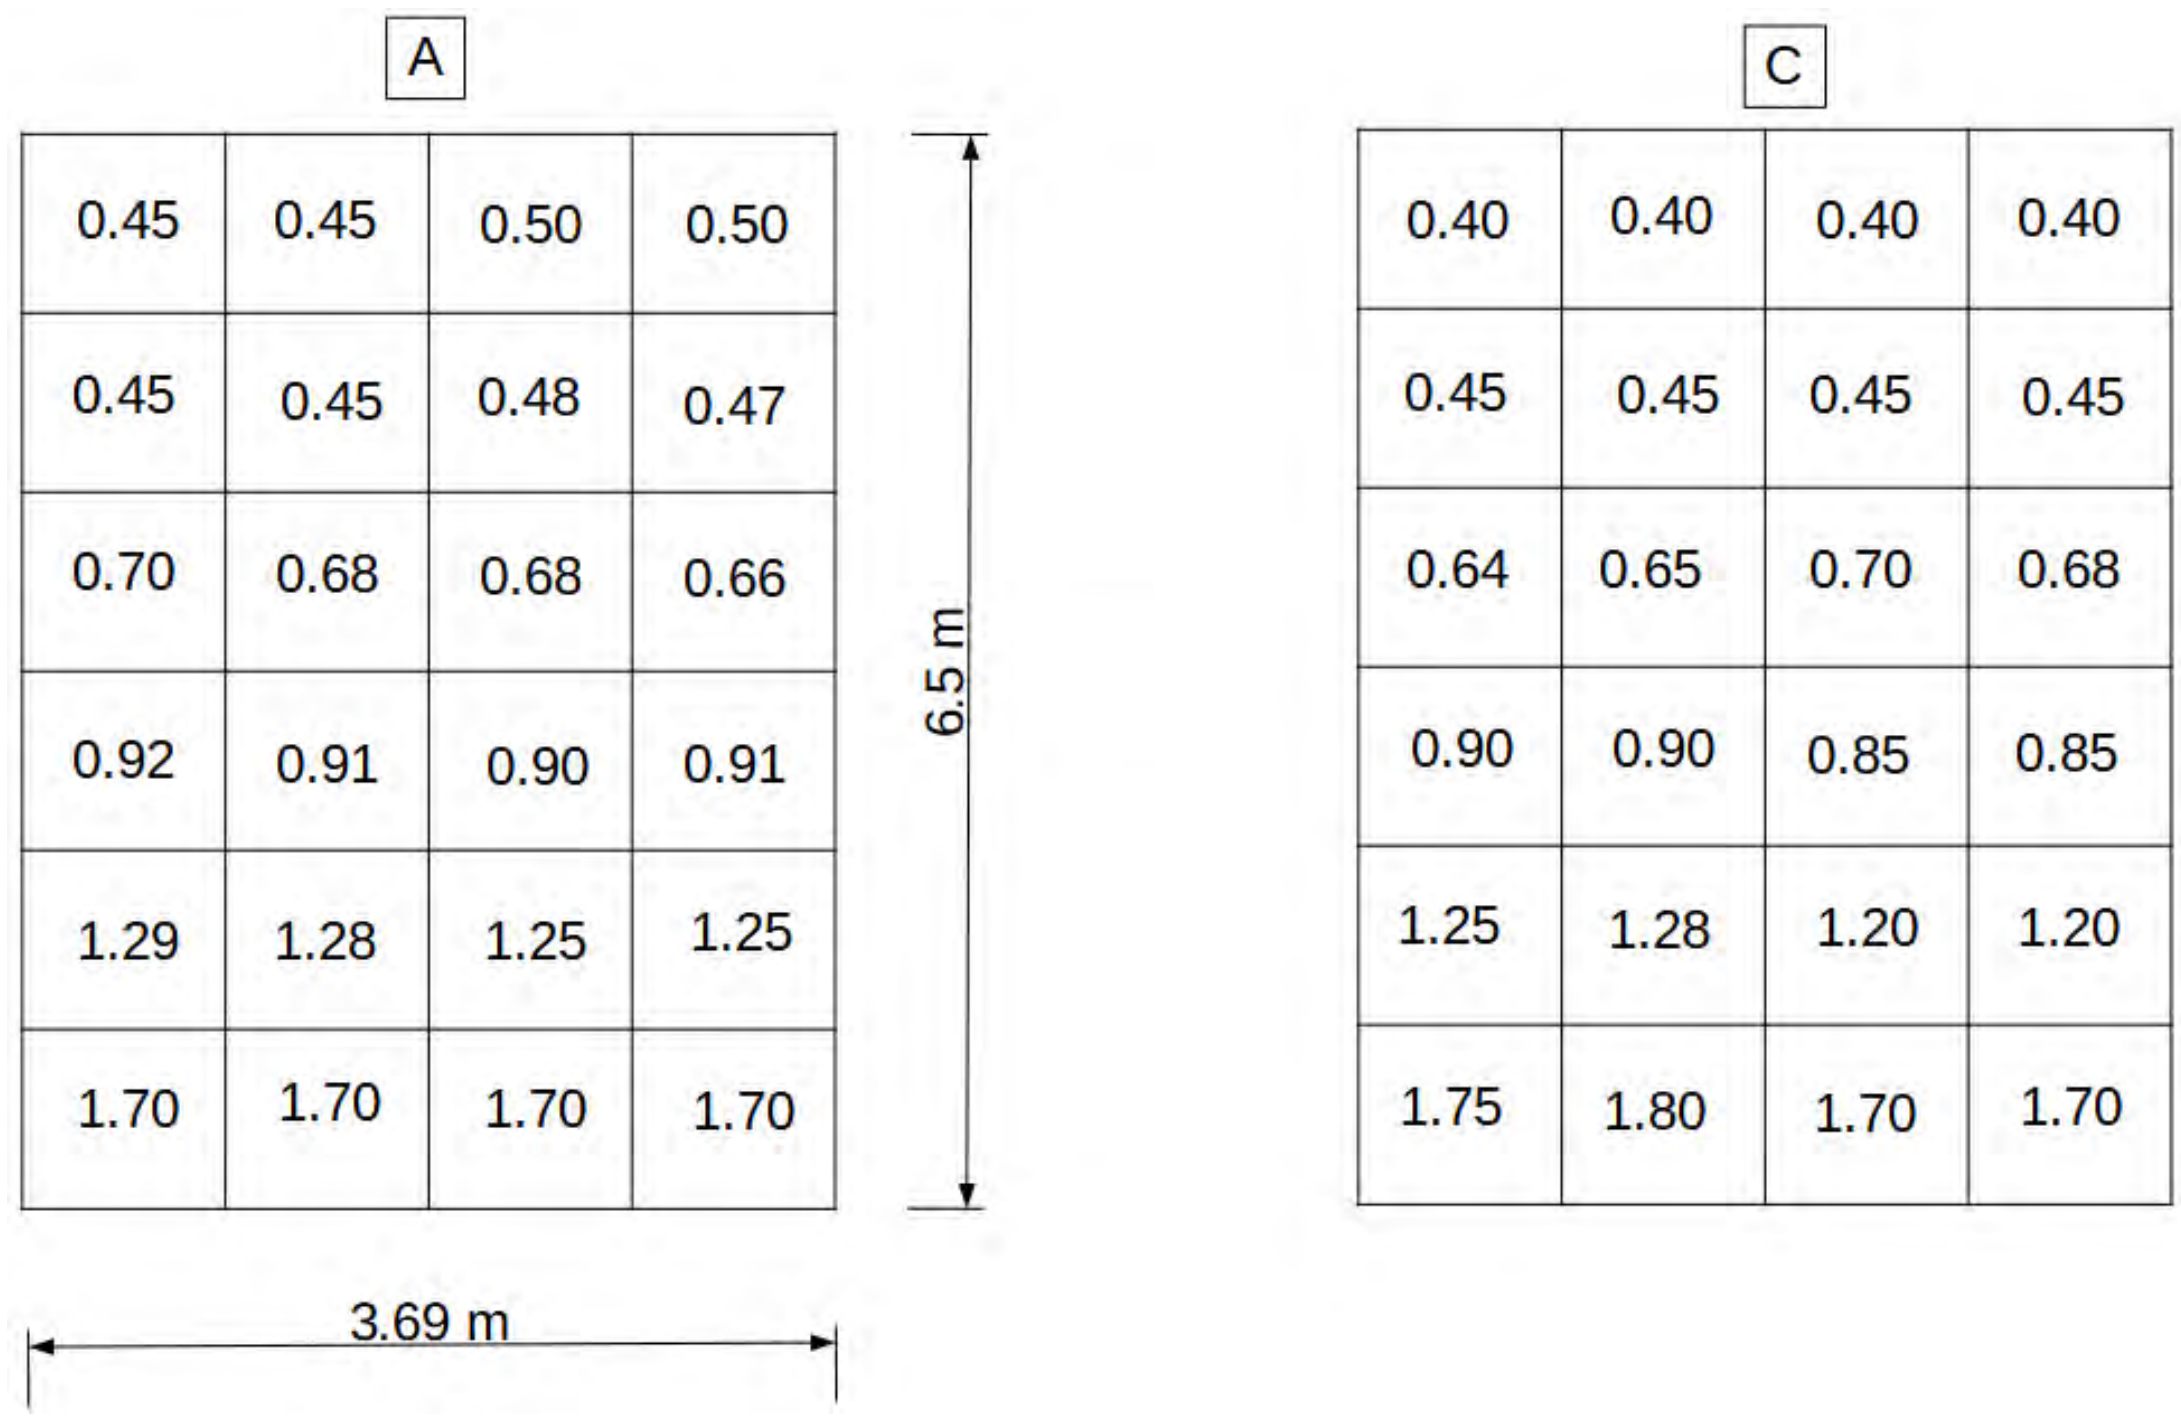
Fig. 6 Gamma-ray dose rate (µSv/h) measured on C, A walls in the nuclear fuel pool

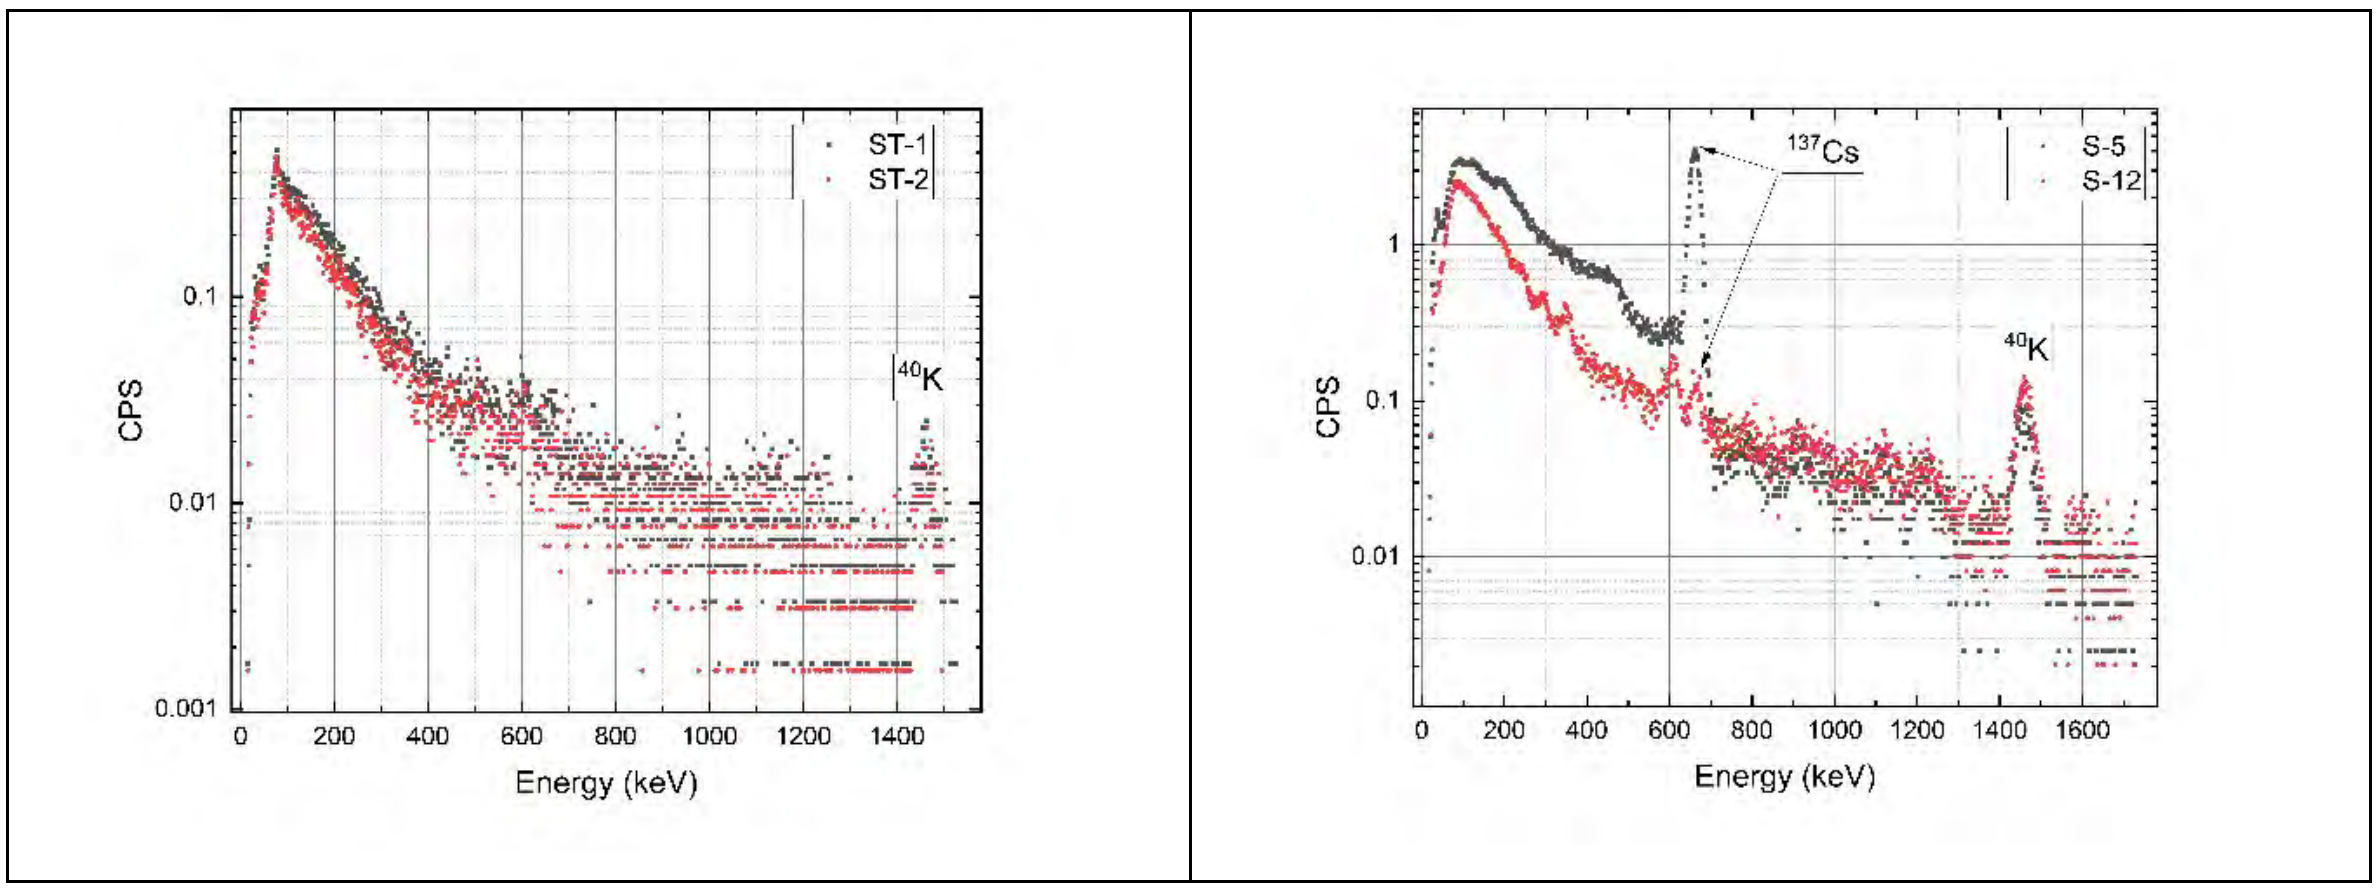
Fig. 7. Spectra of in situ measurements: clean ceiling (left) and contaminated areas of walls (right)

Two areas have been detected with increased activity of Cs-137 (Fig. 7, graph on right). The activity of the contaminated area S-5 (AREA 1) is determined by the Cs-137 gamma activity and is caused by the radioactive substance spill, also confirmed by the sample measurements in the laboratory. The area near the Sarcophagus No. 2 (S-12) shows some enhanced presence of Cs-
