PROJECT 'PURCHASE OF STUDIES FOR THE PREPARATION OF A DESIGNATED SPATIAL PLAN AND THE ASSESSMENT OF IMPACT'

ACTIVITY 4. STUDIES FOR THE ELIMINATION (DECOMMISSIONING) OF THE REACTOR COMPARTMENTS

INTERIM REPORT

RAJALA

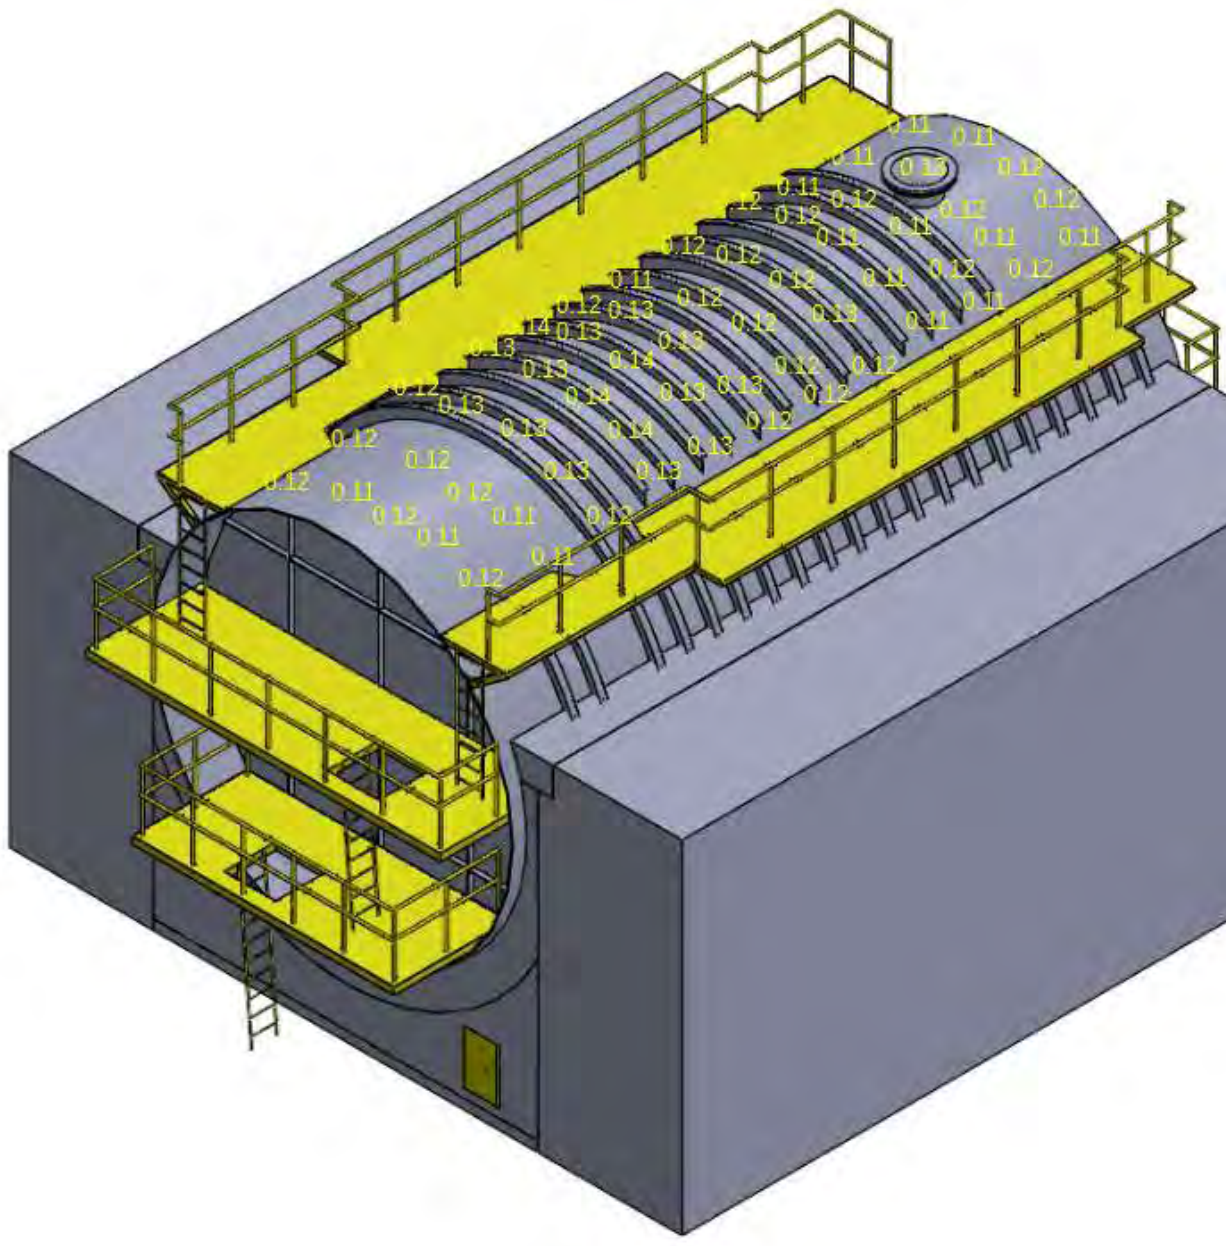
Fig 1. Gamma-ray dose rates (μSv/h) on top of reactor No. 1 structures

The average dose rate value at the ceilings of both sarcophagi was 0.11±0.02 μSv/h. Dosimetry measurements do not say anything about the pollution of the RCs (external) surfaces - the "background" average (0.13±0.02) μSv/h is typical for those rooms everywhere as well as for the metal shell of the compartments.

Higher levels of a gamma-ray dose rate were measured in the rooms below reactors. The maximum value of a gamma-ray dose rate in the room below reactor 2 was 10.5 μSv/h on 16 May 2022. The highest gamma-ray dose rate was in the room below reactor 1, it was 0.4 mSv/h on 16 May 2022. In order to assess the contamination levels in the rooms under the reactors, the gamma spectra have been measured by using the $CeBr_3$ spectrometer to determine the gamma-ray emitting radionuclides content (Fig. 5). The results show that the increase of a gamma-ray dose rate in rooms is caused by Co-60 radiation and measurable activity of radionuclide Cs-137 is not detected. The absence of Cs-137 activity which is found in the areas, where is contamination of the reactor origin, one could assume that contamination is absent. This conclusion was confirmed by measurement of smear samples in the laboratory.

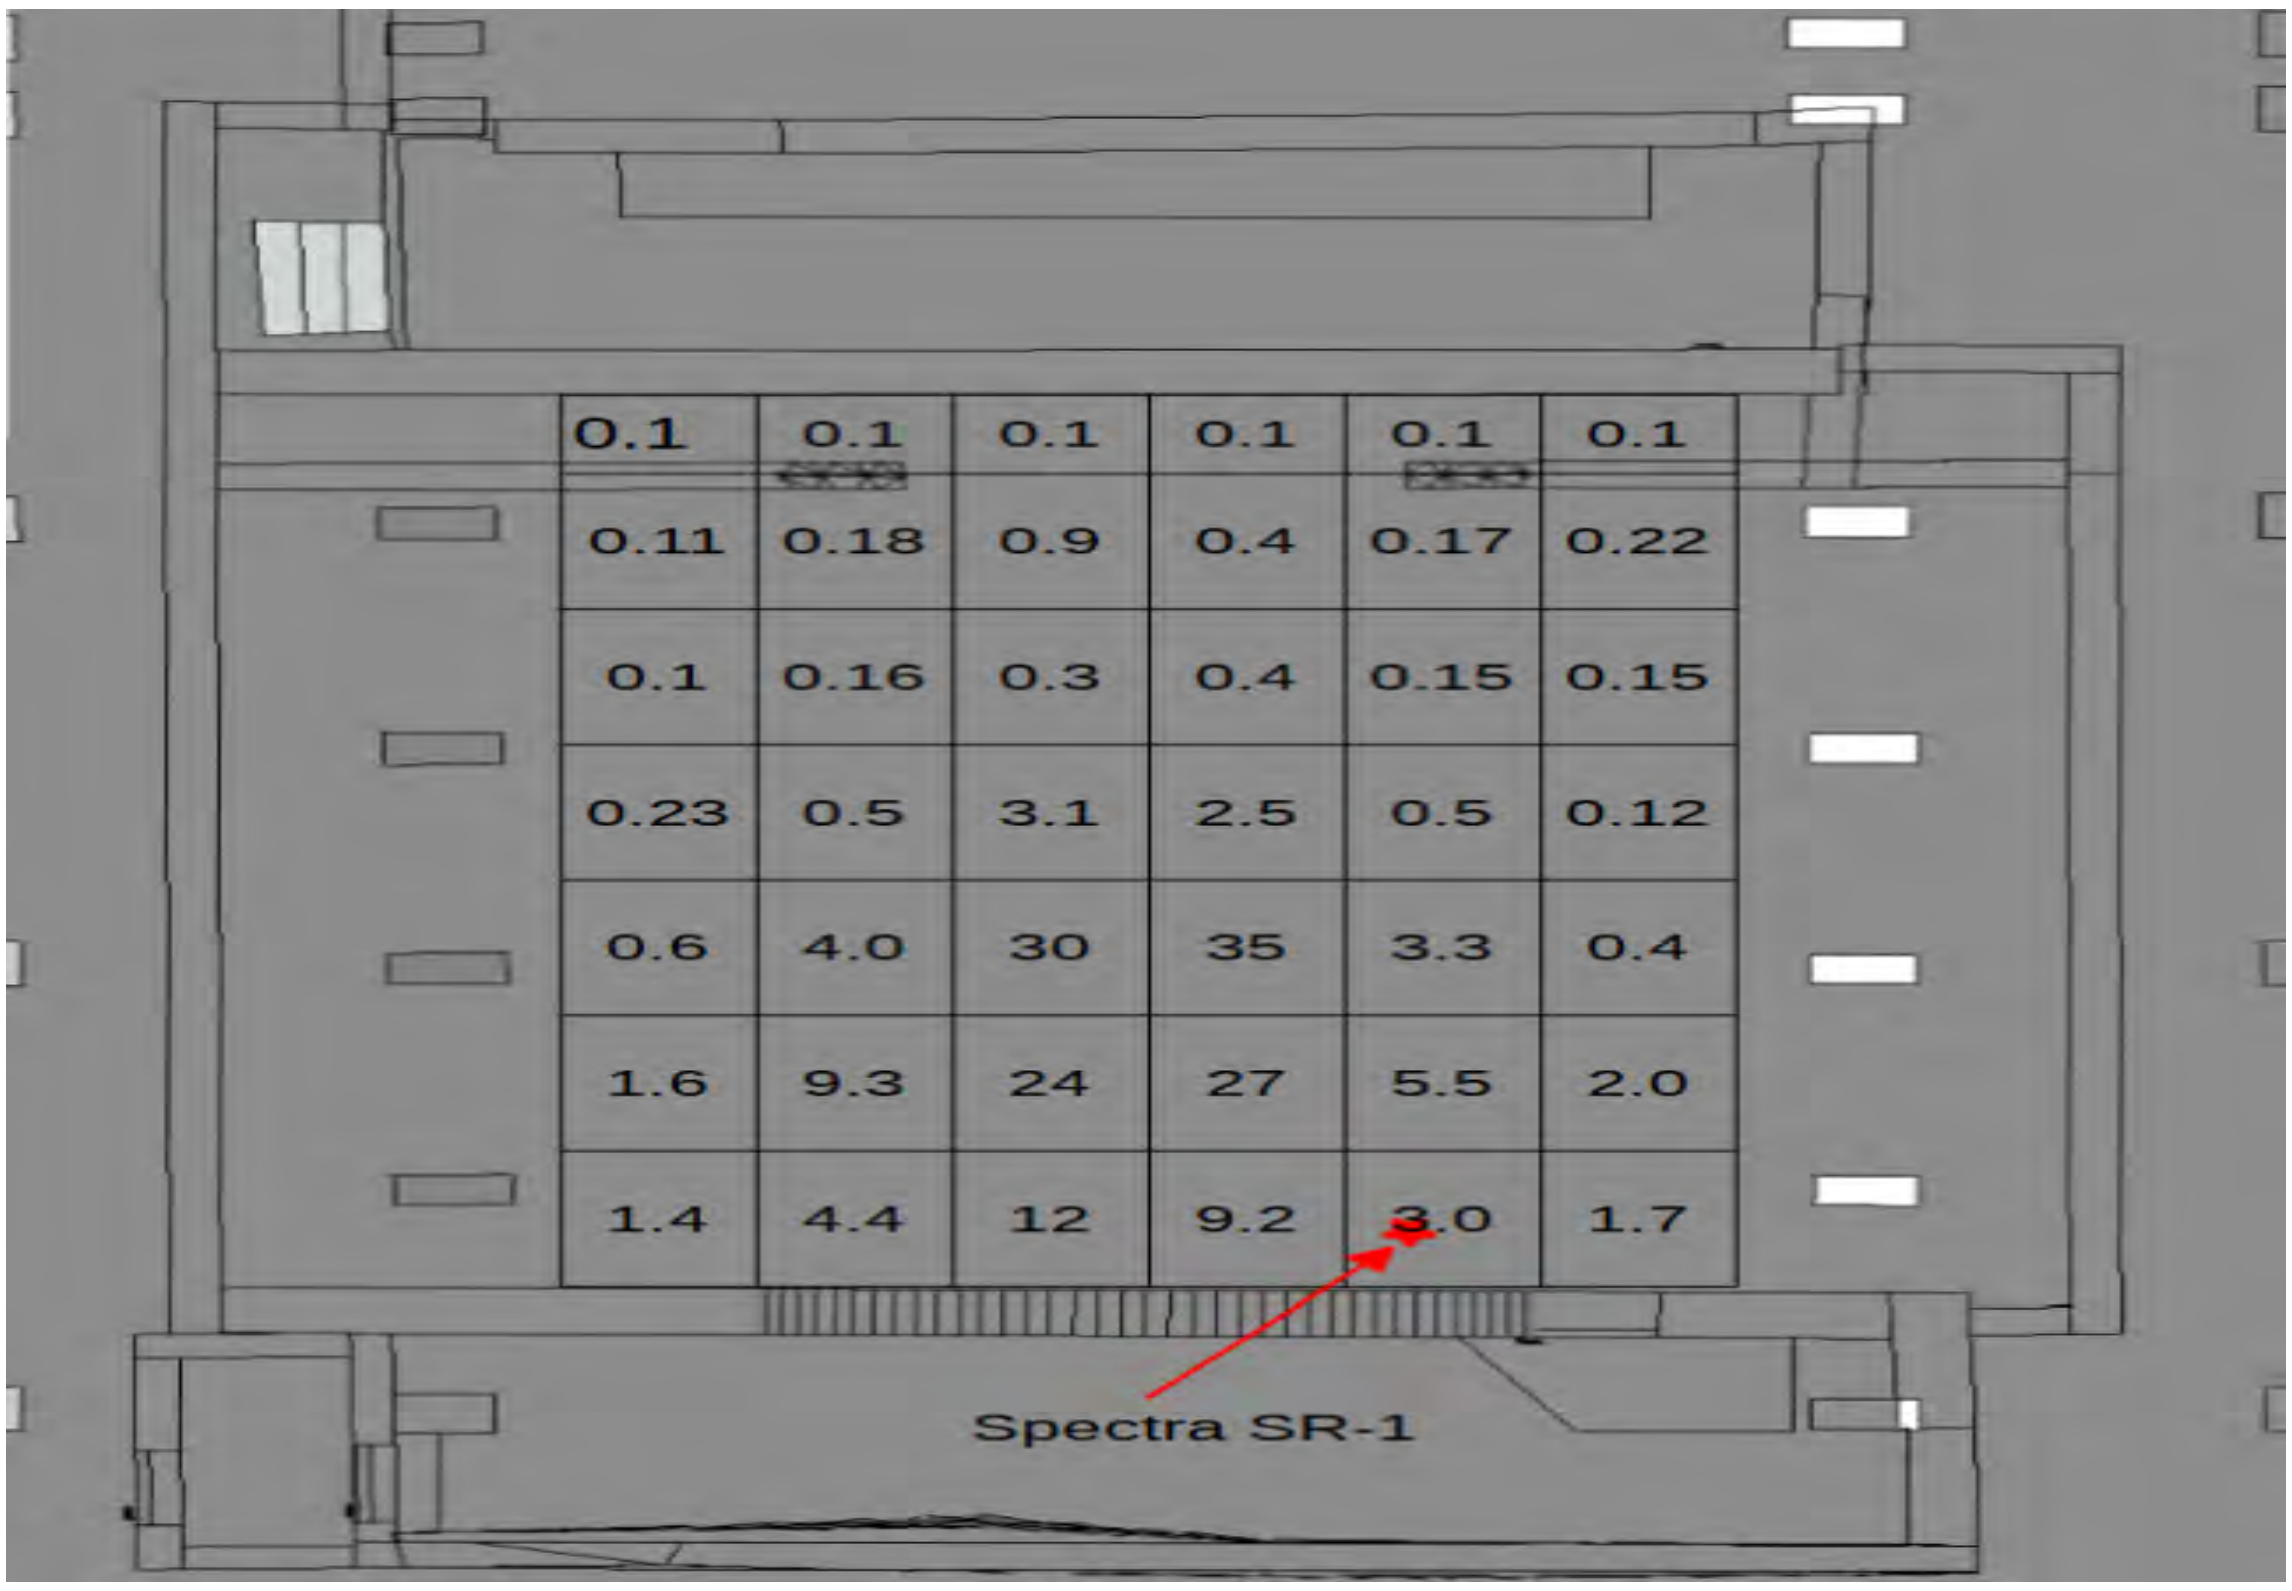
Fig. 3. Gamma-ray dose rates (μSv/h) in the room under the reactor No. 1 1 m above the floor

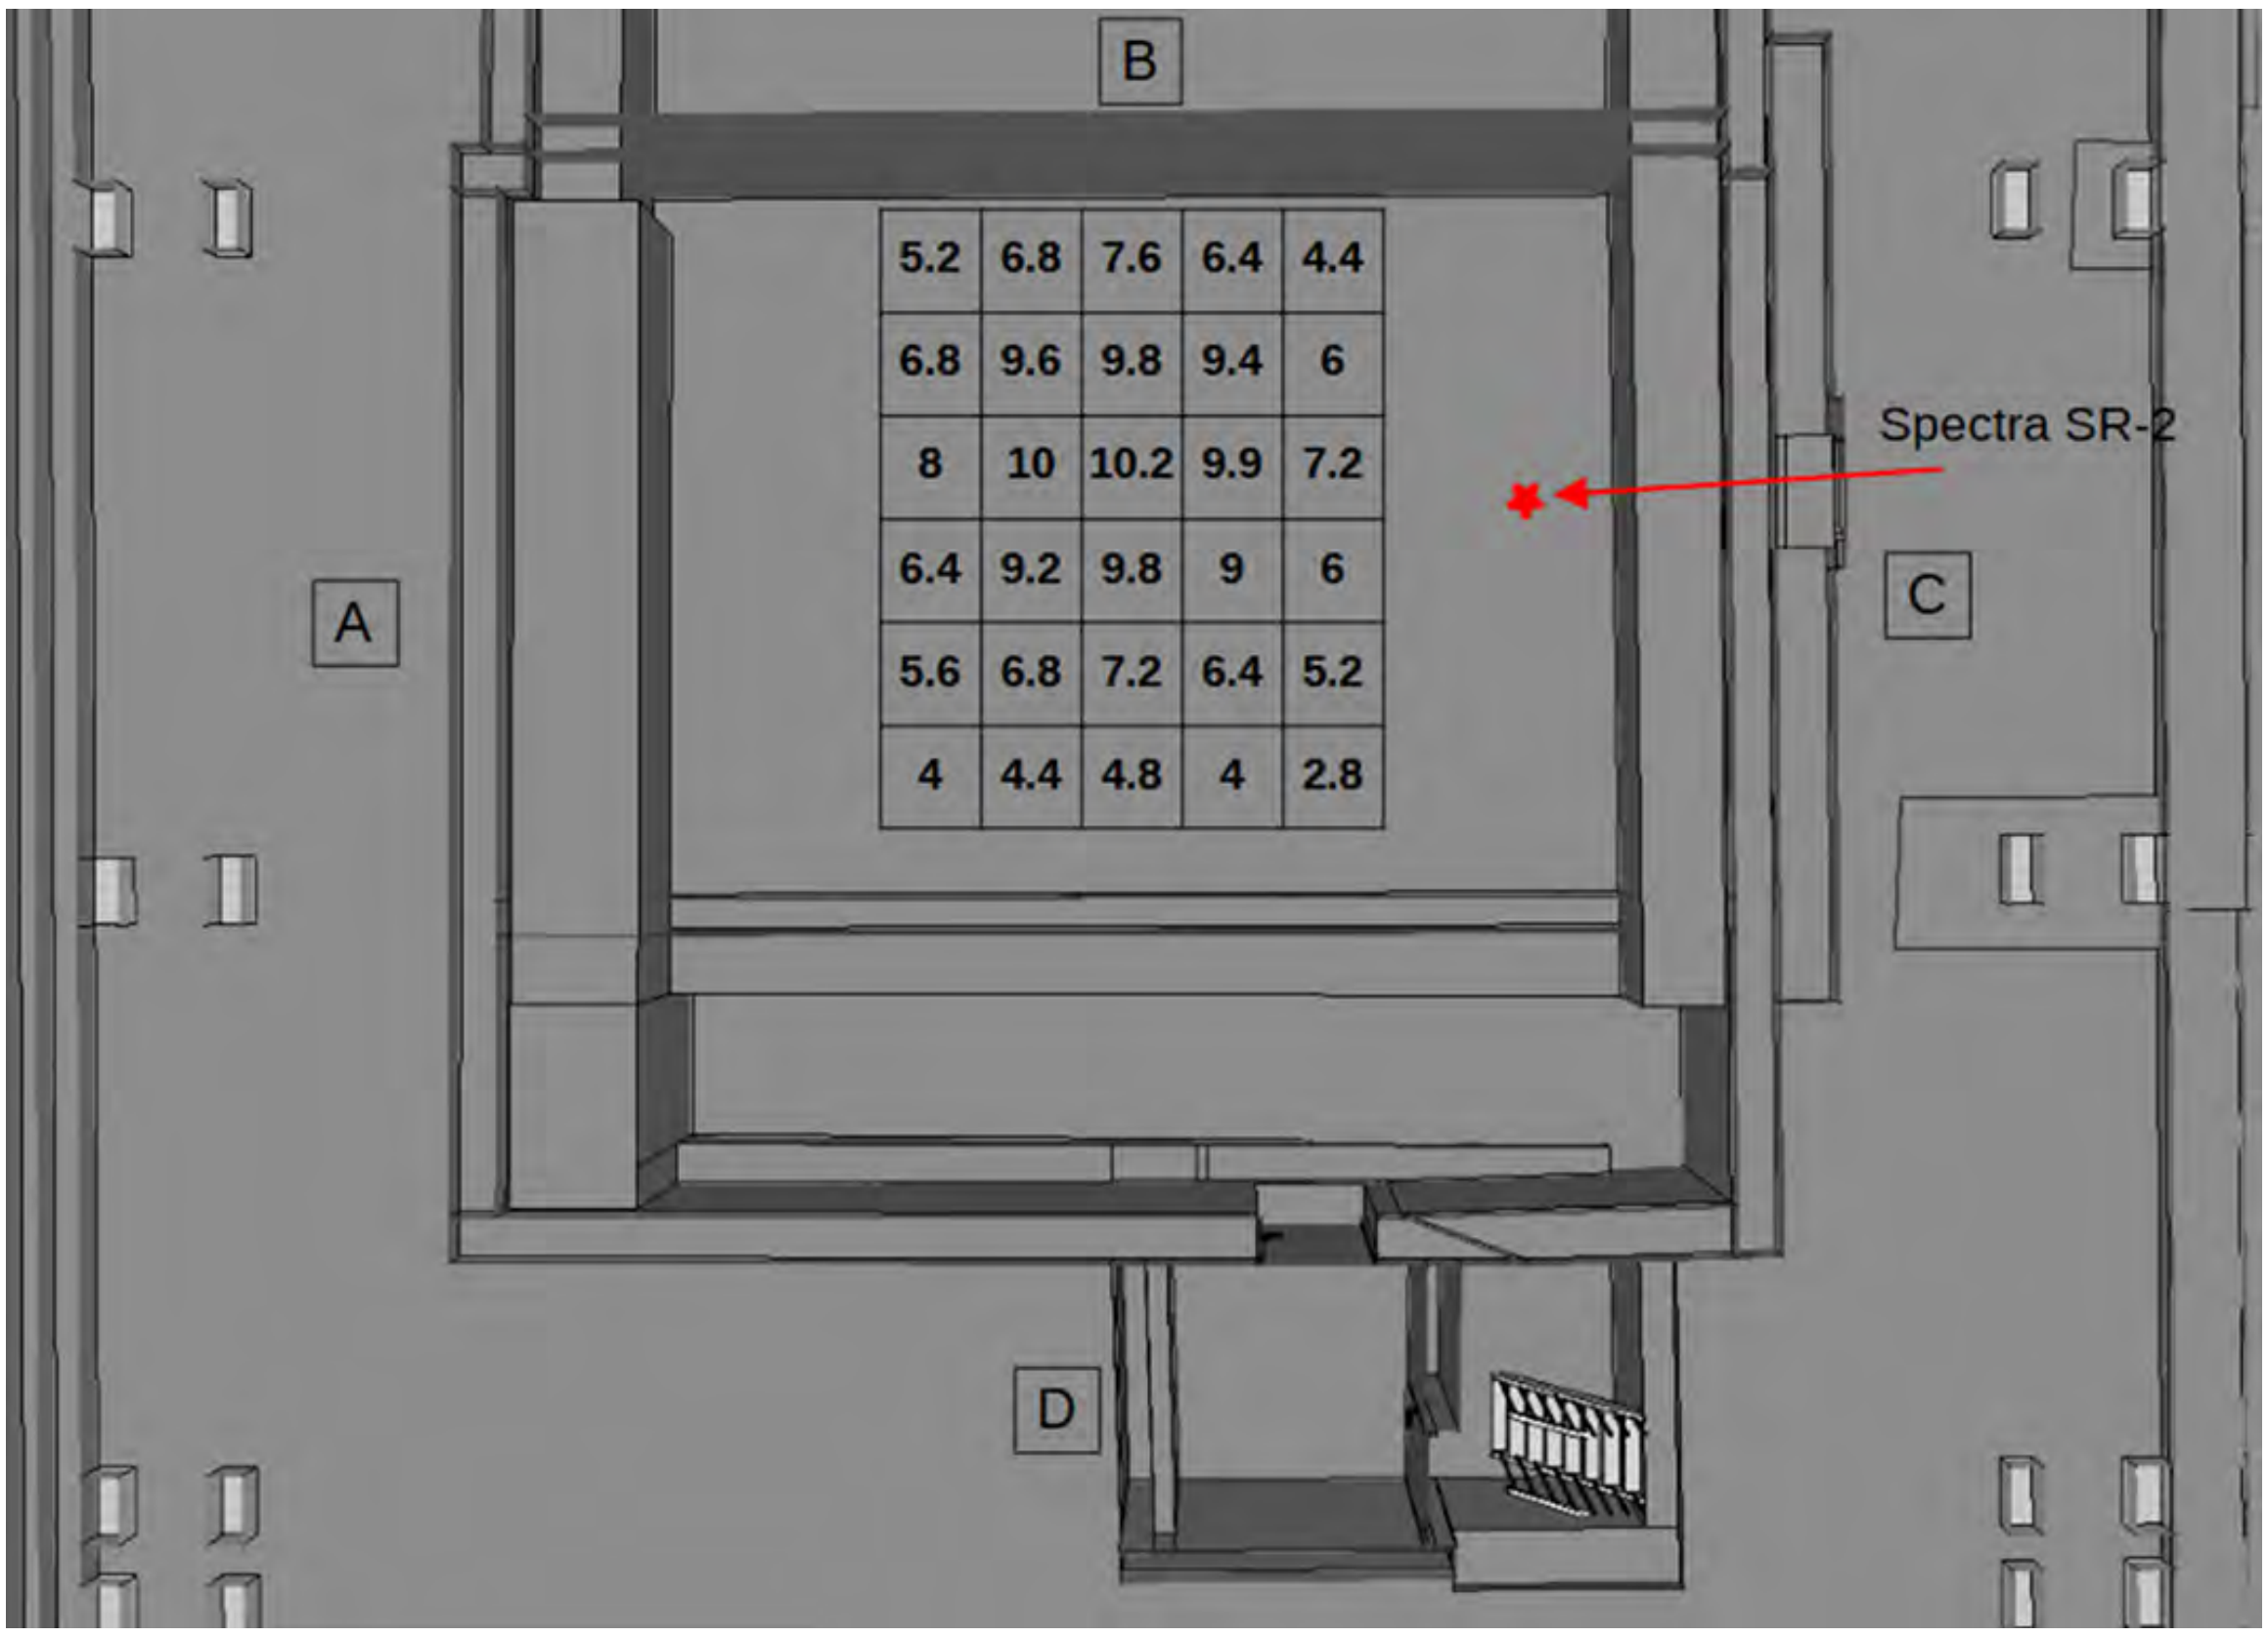
Fig. 4. Gamma-ray dose rates (μSv/h) in the room under the reactor No. 2 1 m above the floor

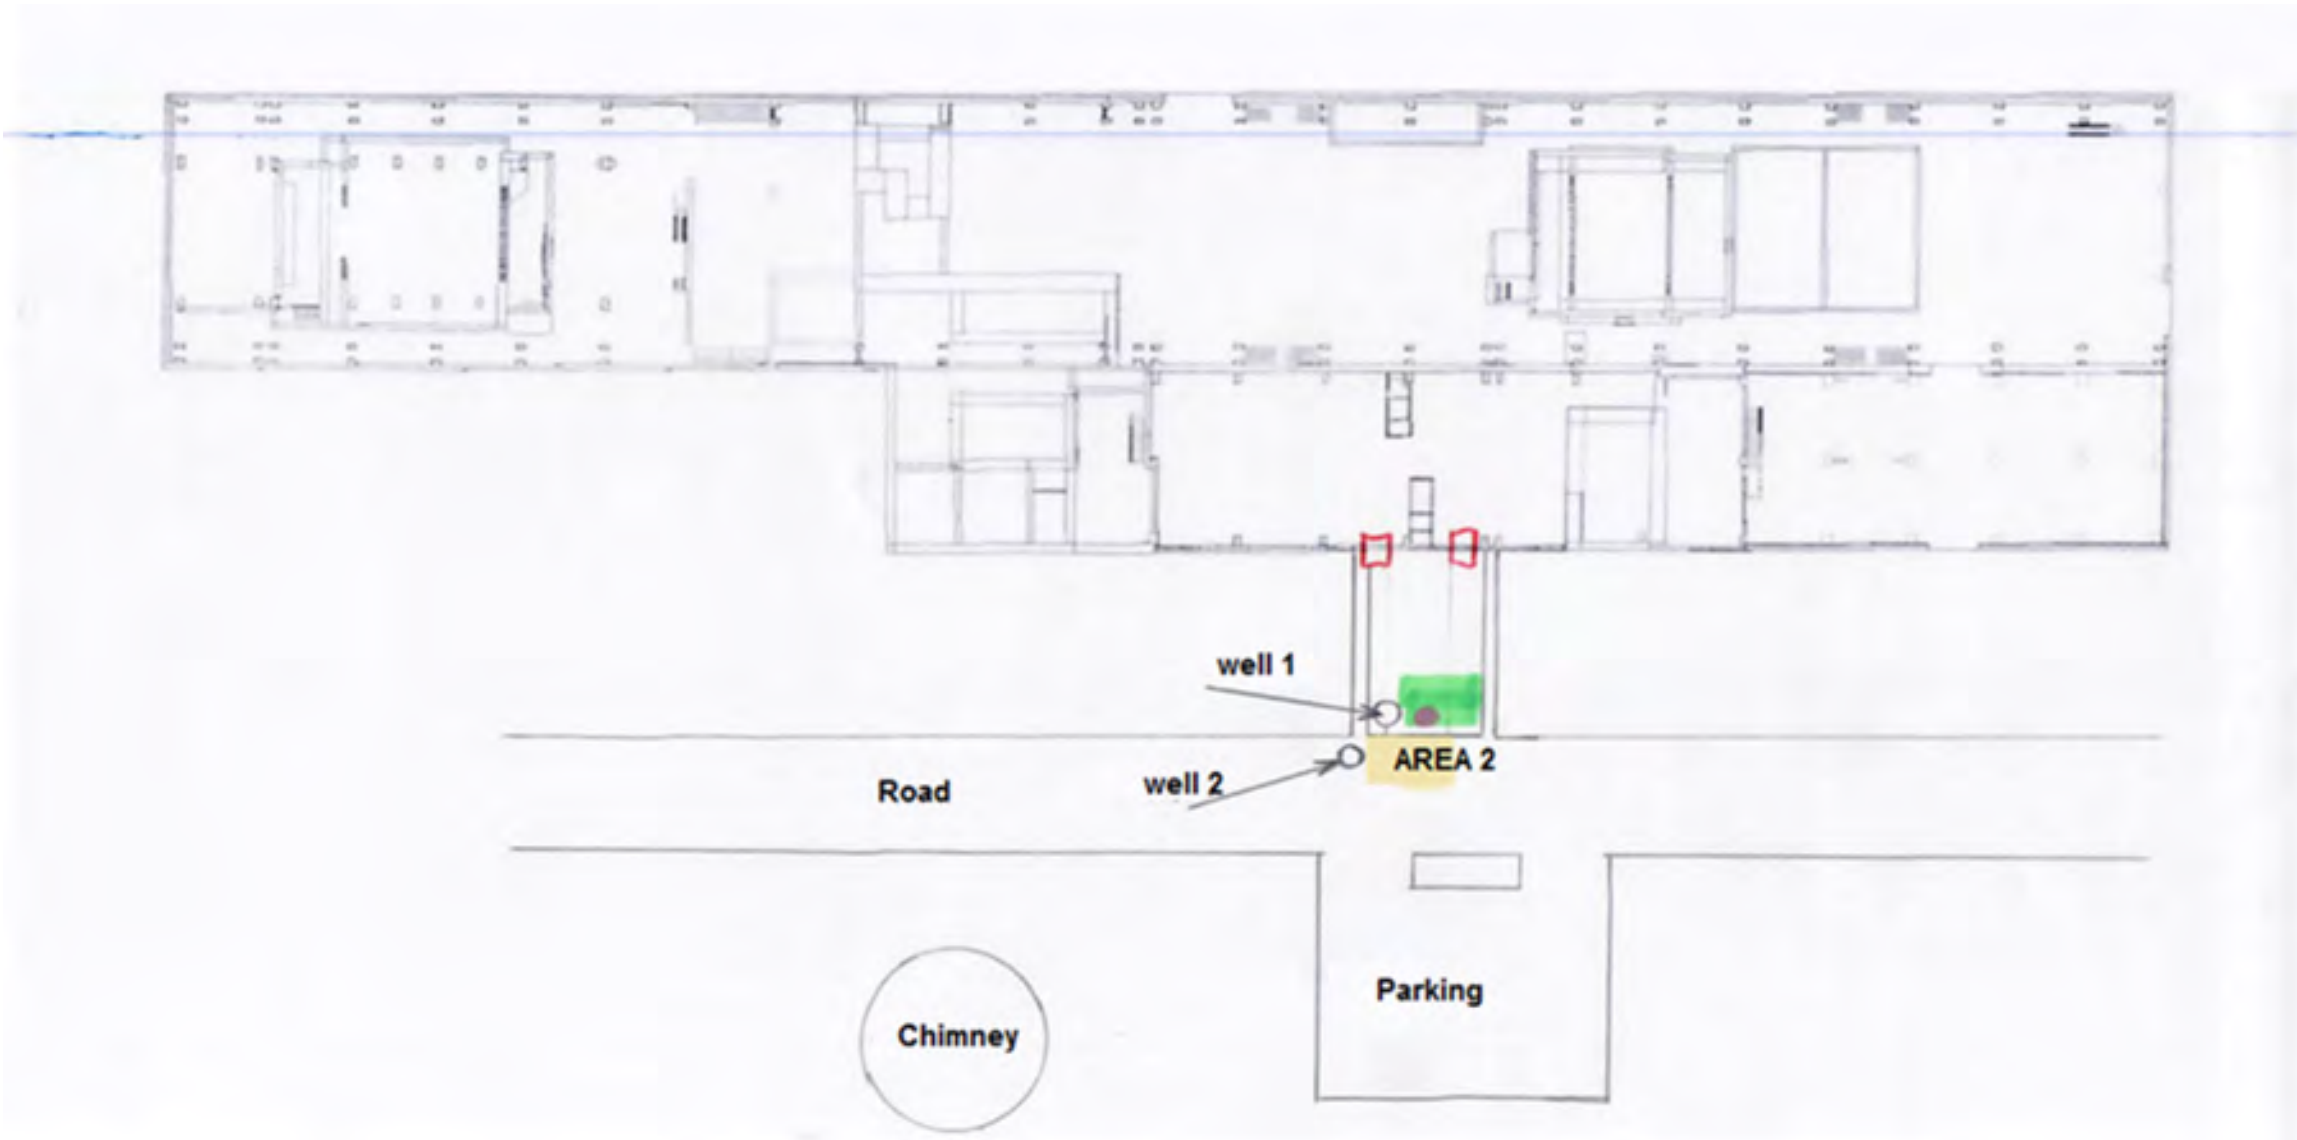
Some increase of an ambient dose rate of up to 0.15-0.16 µSv/h was determined in a few points near MB, which are caused, the most probably, by radiation from MB. A similar effect can be noticed for the lines, which cross the contaminated area (AREA 2). AREA 2 is the only contaminated area on the territory of FPNC. The result of scanning exceeded 0.20 µSv/h in AREA 2. AREA 2 is located at a distance of about 30 m from MB to the North direction (see Fig. 5). Contaminated area is marked in Fig. 3 by two colours: green and yellow. Yellow marking shows a place on the asphalt road, while the place with the detected higher dose rate on the grass is marked green. AREA 2 also includes a storm drain well (well 1 on Fig. 6). Additional measurements of the gamma-ray dose rate and in-situ gamma spectrometry measurements were done to define the affected area with better than 0.5 m uncertainty. The dose rate in AREA 2 on the grass surface varied from 0.11 µSv/h to 0.22 µSv/h (Fig. 6). This shows that the contamination on AREA 2 is non-homogeneous, there are smaller areas with no contamination inside a larger area with enhanced levels which on the grass surface can be evaluated as high as a doubled background radiation level. Furthermore, the highest dose rate measured at the spot located on the asphalt road was 0.24 µSv/h. The total contaminated area is up to 30 m^2.

Fig. 5. Contaminated area (AREA 2) at the territory of FPNC

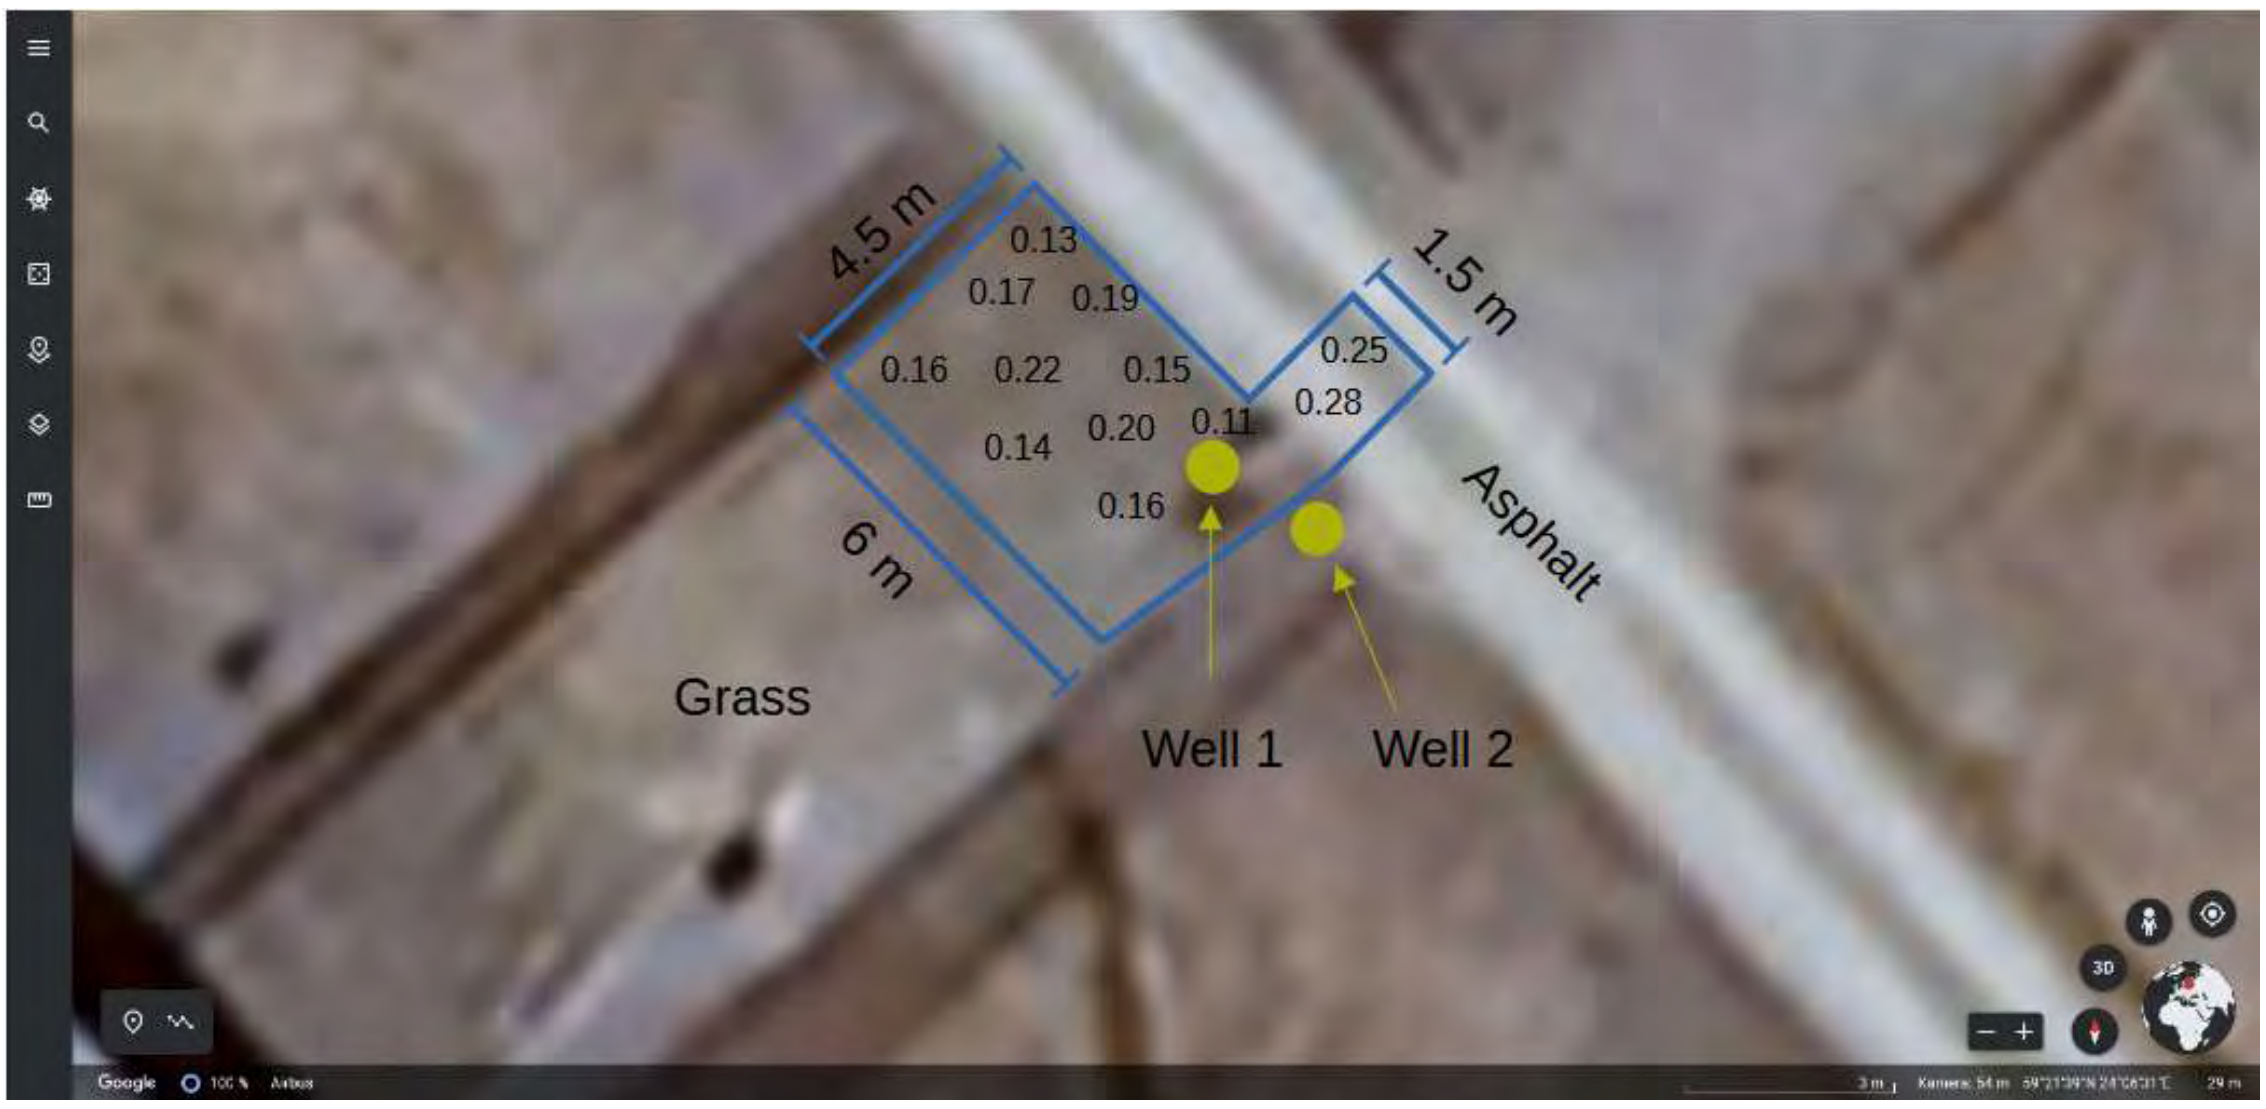
Fig. 6. Contaminated area (AREA 2) at the territory of FPNC, gamma-ray dose rate

The average ambient dose rate value in the survey unit No. 2 was determined as 0.13 ± 0.02 µSv/h. Higher variation of the observed dose rate was governed by elevated levels at a number of points where natural radioactivity from massive stones was determined. For instance, the dose rate value at the surface of some stones was measured as high as 0.6 – 0.7 µSv/h.

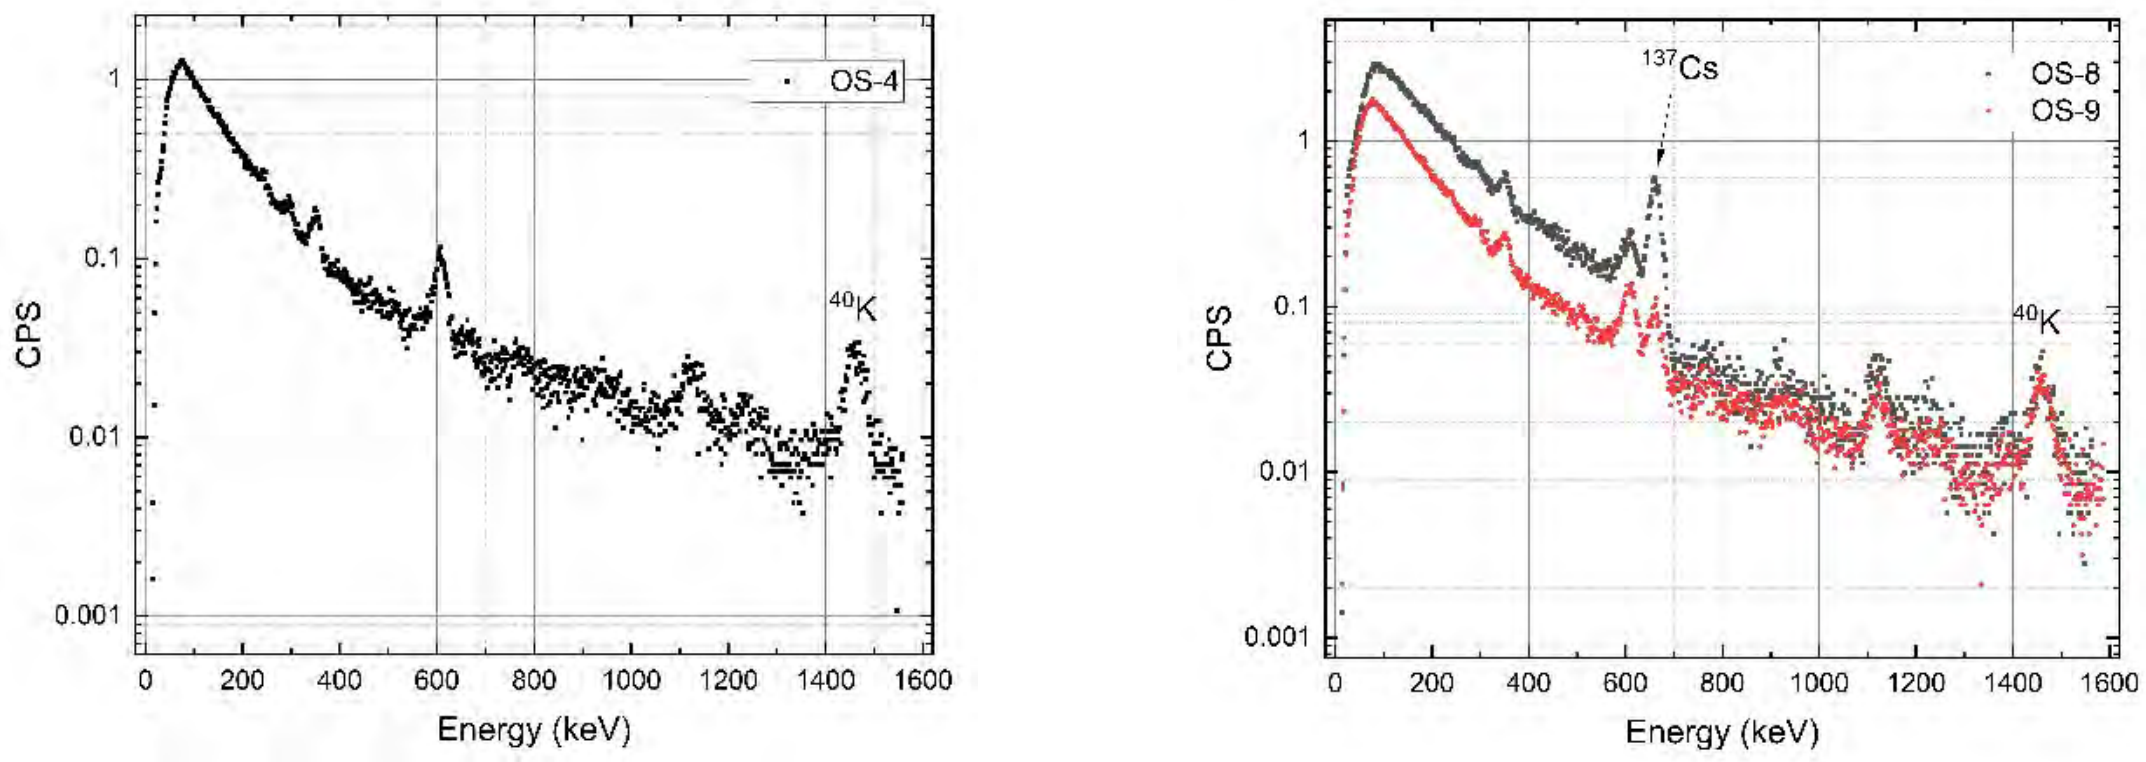
Fig.7. Normalised in situ gamma spectrum of natural background radiation (left) and contaminated area near the well (right)

The second campaign has been targeted to confirmation of preliminary results and more detailed characterisation of the contaminated area. The gamma-ray spectrometric in situ measurements have been done to get additional information on the gamma emitting radionuclides at FPNC. The spectrometric in situ measurements have been performed by using gamma spectrometer with a $CeBr_3$ detector. There have been spectrometric measurements done at various depths inside well 1. 4 spectrometric measurements have been done in the area where no contamination was found and 4 measurements in AREA 2. It is important to note that these measurements were qualitative, dedicated for gamma emitters – which primary determines the dose rate – identification and later on the quantitative measurements of samples were performed both using destructive and non-destructive nuclear spectrometry methods. The normalised in situ gamma spectra of natural background and of the contaminated AREA 2 the near well have been measured (Fig. 7).
